STEEL BUILDING DAMAGE FROM THE CHRISTCHURCH EARTHQUAKE OF FEBRUARY 22, 2011, NZST

Michel Bruneau¹, Charles Clifton², Greg MacRae³, Roberto Leon⁴, and Alistair Fussell⁵

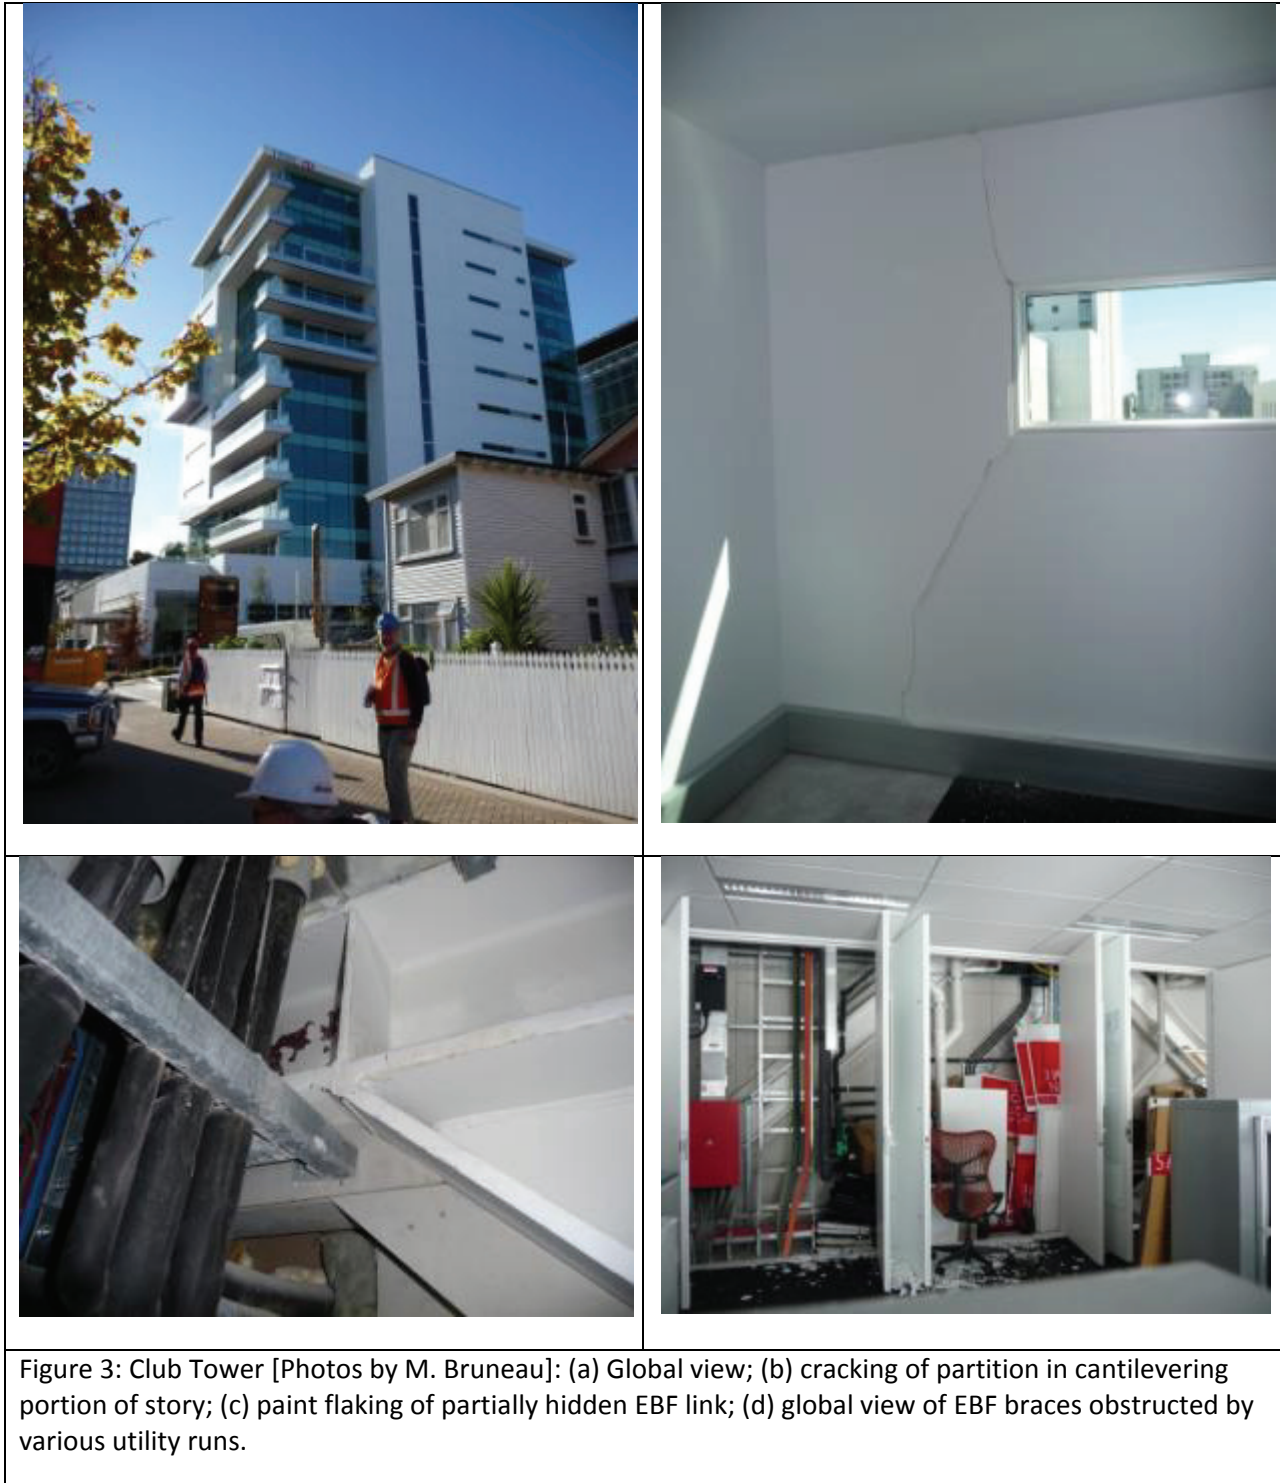
The Club Tower Building (Figure 3a) has eccentrically braced frames located on three sides of an elevator core eccentrically located closer to the west side of the building, and a ductile moment resisting frame (DMRF) along the east façade. The steel frame is supported on a concrete pedestal from the basement to the 1st story, and foundations consist of a 1.6m thick raft slab. Only the EBFs on the east side of that core could be visually inspected without removal of the architectural finishes (Figure 3d). As observed following the September 2010 (Bruneau et al. 2010), evidence of inelastic deformation was limited to flaking of the brittle intumescent paint on the EBF links at some levels (Figure 3c), however later investigations have shown slightly more yielding in the active links of EBFs in the East-West direction. The links were free of visible residual distortions. Previously reported slab cracking (Bruneau et al. 2010) could not be detected as the concrete floor slab was covered by floor carpeting, except at one location at the fixed end of a segment of the floor cantilevering on one side of the building (a feature present only over two stories for architectural effect). Crack widths appeared similar to what had been previously observed. Substantial shear cracking of the sheetrock finish on the exterior wall of that cantilevering part of the floor was also observed (Figure 3b); only hairline cracking of sheetrock finishes was observed elsewhere throughout the building. One non-structural masonry block installed for sound proofing purposes adjacent to mechanical units on the pedestal roof suffered minor shear cracking where it had been placed hard against a cantilevering floor beam. .

Given the magnitude of the earthquake excitations, with demands above the ULS design level, substantial yielding of the EBF links would have been expected. EBFs designed in compliance with the NZS 3404 (SNZ, 1997/2001/2007) provisions are typically sized considering a ductility factor (μ , equivalent to R_{μ} in US practice) of up to 4, a level of link deformations that would correspond to significant shear distortions of the links. Yet, only minimal flaking of the paint in the EBF links was observed. Beyond the usual factors contributing to overstrength in steel frames (e.g. expected yield strength exceeding nominal values, modeling assumptions, etc.), a number of additional factors can explain behavior in this particular case, including strength of the composite floor slab action (neglected in design), mobilization of the solid non-structural wall concrete cladding adjacent to the staircase and the relatively short duration of earthquake excitation.

The ductile MRF along the east wall did not show any evidence of yielding. Its design had been governed by the need to limit drift, particularly under torsional response due to the eccentricity of the core, and its corresponding effective ductility factor (μ) was low at 1.25.

Overall, the building was designed for a lower level of structural ductility demand than is typical for an EBF due to its height and plan dimensions, and performed well during the earthquake.

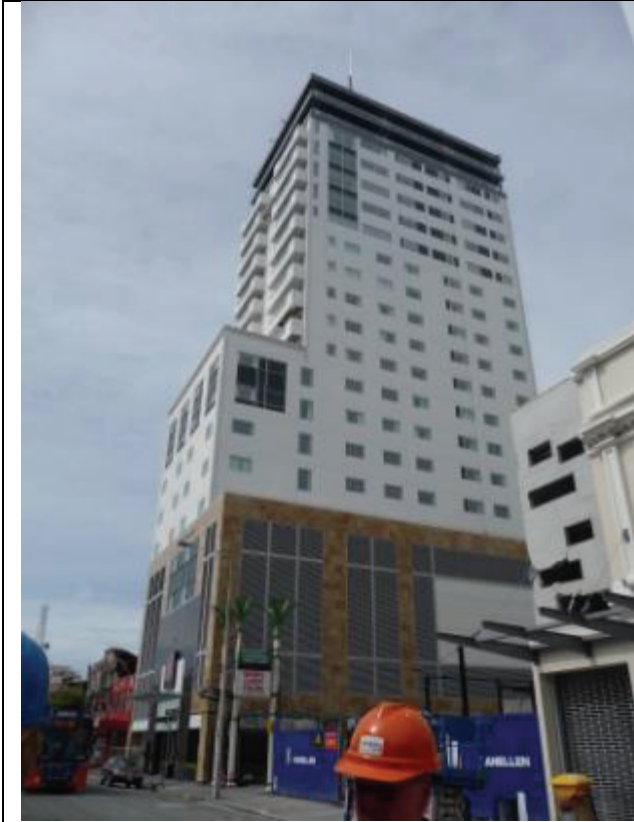
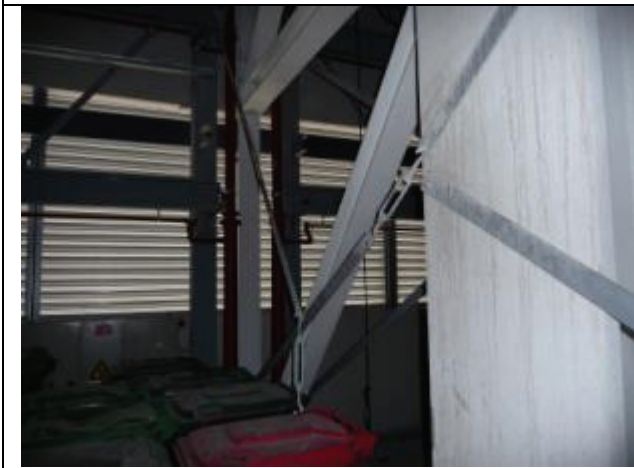
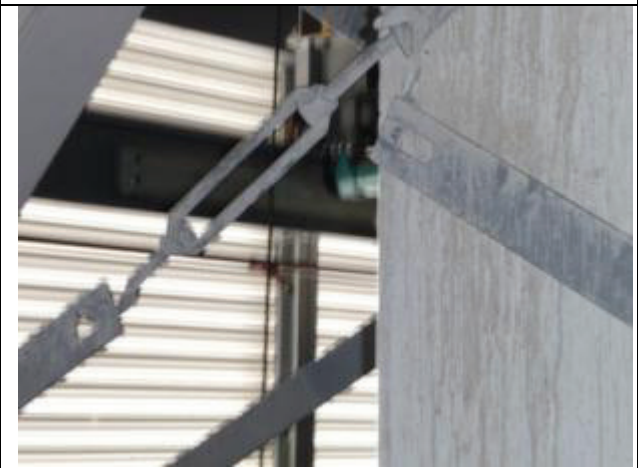
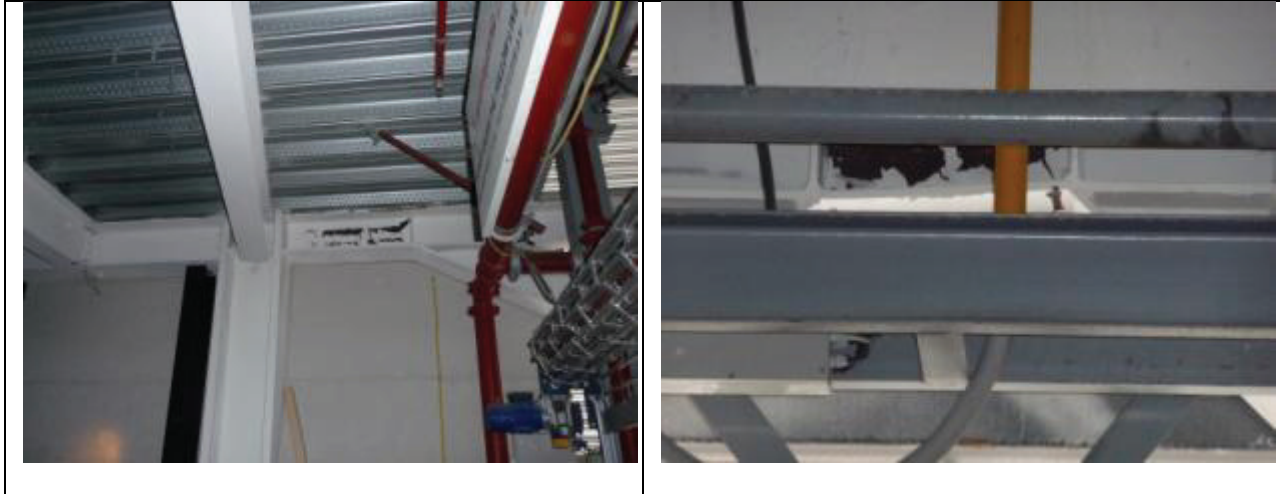
As a new landmark and the tallest building on the Christchurch skyline⁶, the 22-storey Pacific Residential Tower consists of perimeter EBFs up to the six floor (one on each building face), shifting to EBFs around the elevator core above that level, with a transfer slab designed to horizontally distribute the seismic loads at that transition point. EBFs at levels below the transfer slab were visible, as these levels housed a mechanical multilevel parking elevator system. The separate bracing system of that mechanical device consisted of flat plates connected with turnbuckles and hooks. Some of those details failed as the bars un-hooked when returning into compression after tension yielding excursions that elongated the braces. The EBFs at intermediate locations were not integral with the floor slab and so did not benefit from the strength increase provided at lower stories. A range of views for this structure are given in Figure 4.

Paint flaking and residual link shear deformations were observed in the EBF links at those levels. Design of the EBFs in that building was governed by the need to limit drift, with a corresponding resulting design ductility factor (μ) of 1.5 (even though up to 4.0 is permitted for EBF, as mentioned earlier). This is typical of EBFs in tall buildings in New Zealand's moderate to low seismic zones; Christchurch is moderate in accordance with the earthquake loadings standard, NZS 1170.5. The EBF at all other levels were hidden in architectural finishes, and absence of damage to those finishes suggested limited inelastic deformation, except at level six where a few of the hotel room doors along the corridor could not be closed, which suggests greater residual deformations at that level. More detailed investigation of that level is a priority for detailed evaluation.

Figure 4 Pacific Tower [Photos by M. Bruneau]: (a) Global view; (b) and (c) multistory mechanical garage failed braces; (d) Flaked paint on EBF link; (e) Residual shear deformations of EBF link.

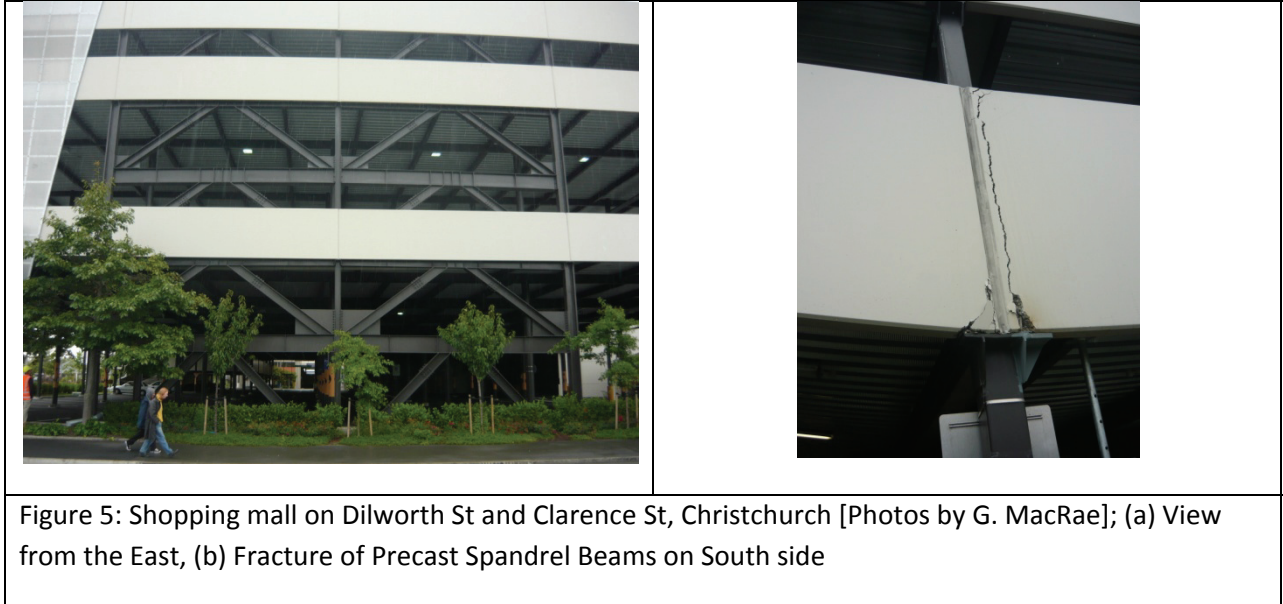
The EBFs in a three level parking garage of a shopping mall west of the CBD did not exhibit inelastic deformations (Figure 5a), however there was some evidence of minor movement of the bolted splice connections in the braces. The basically elastic response of the EBFs is not surprising in this case, given that these frames had been designed to accommodate three additional parking levels to be added at a later time and the intensity of shaking was lower than in the CBD. Live load present at the time of the earthquake may also have been less than considered in design, although it was higher than in the September earthquake when the shopping mall was not occupied. Movement of precast units previously reported was observed to have intensified. This resulted in fracture of the spandrel panels beside the epoxy mastic connection between panels presumably indicating that the epoxy mastic was stronger than the precast panels in tension (Figure 5b). These fractures occurred in all panels over the height of the structure. These spandrel panels were also designed to carry gravity loads in the parking structure so their fracture compromised the serviceability of the building.

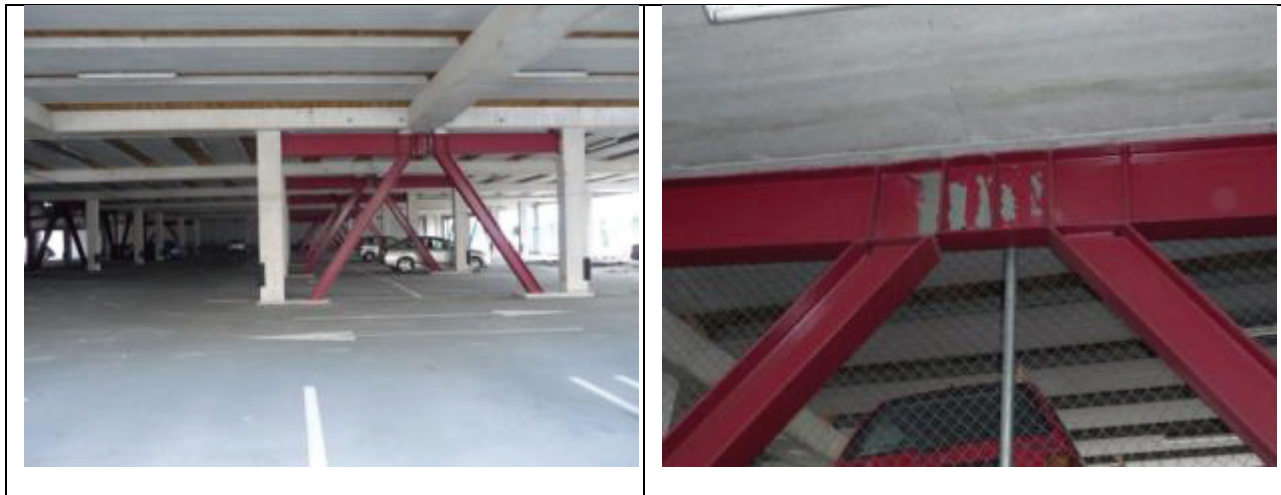
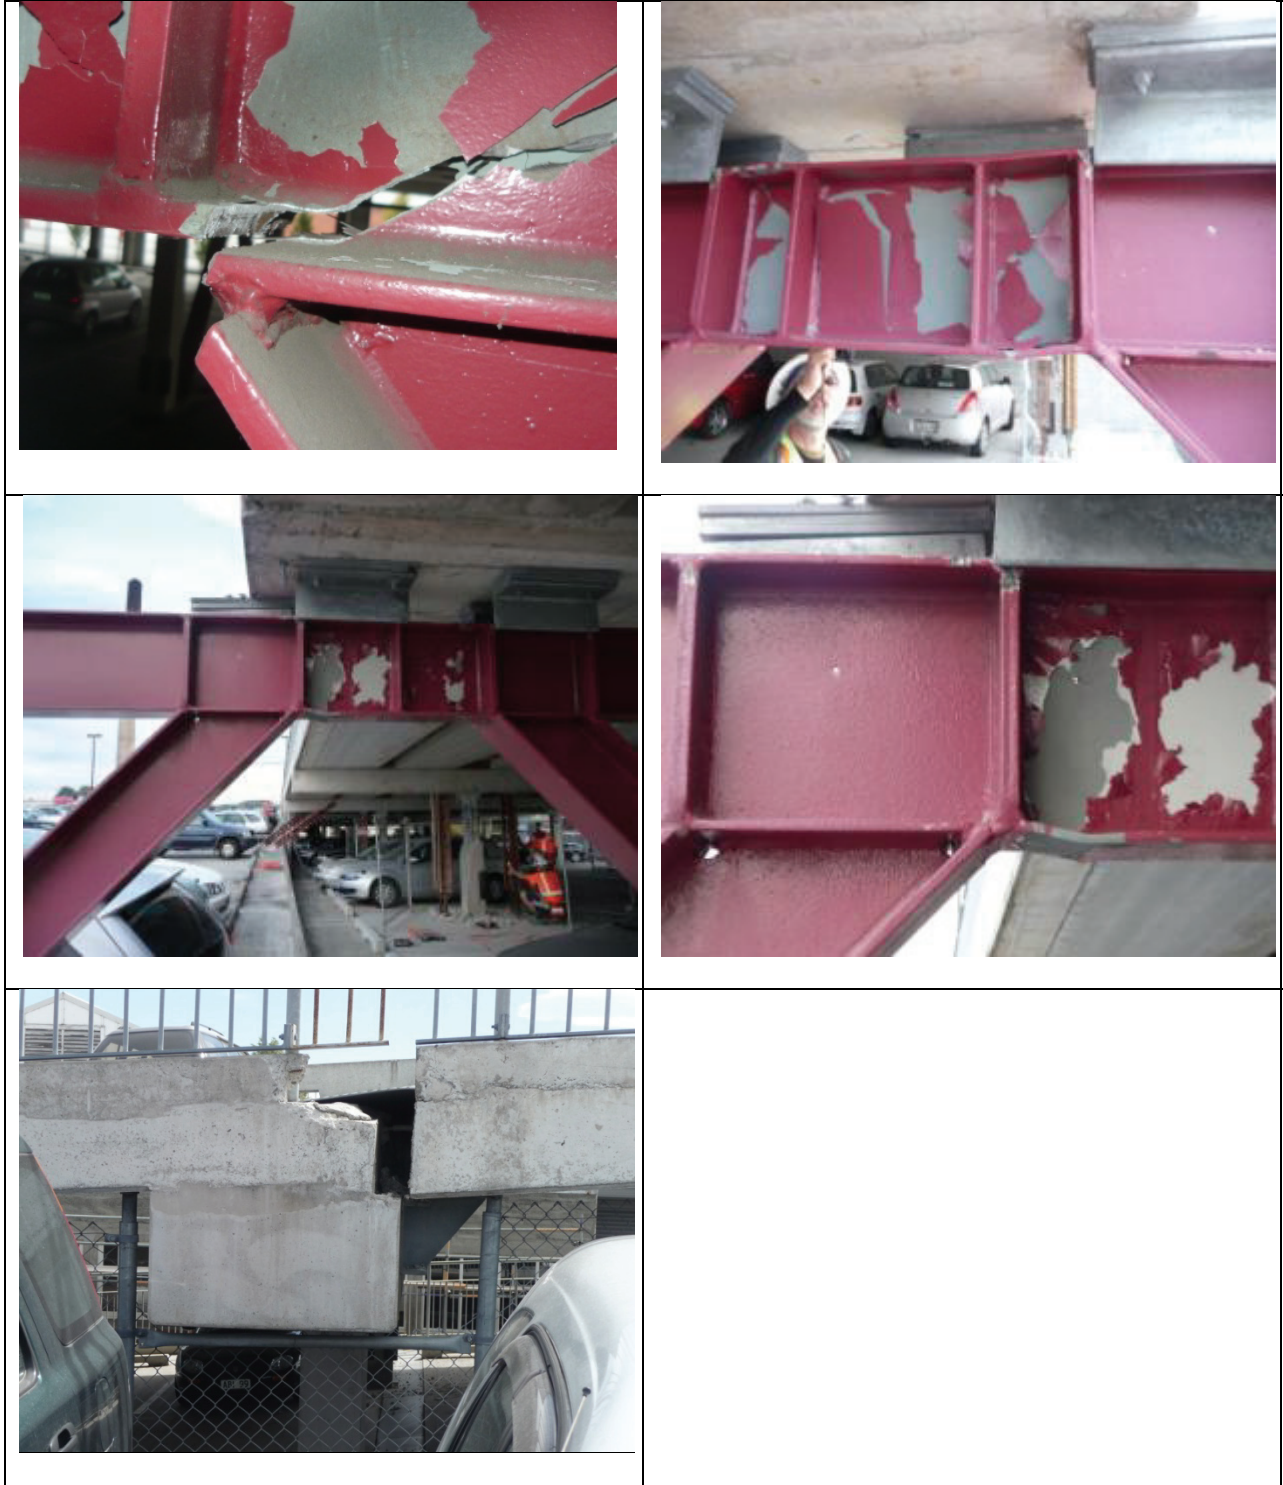
The EBFs in a hospital parking garage closer to the epicenter (Bruneau et al. 2010) also performed well, although some link fractures were observed in two braced bays (Figure 6). Note that at least six EBF frames were used at each level in each of the buildings' principal directions, and that this significant redundancy contributed to maintain satisfactory seismic performance of the building in spite of those significant failures. Residual drifts of the parking structure were not visually noticeable, which suggests that these fractures would have not have been discovered if hidden by non-structural finishes.

Note that this parking structure was also designed to accommodate two additional floors. Yet, some of the links at the first story showed paint flaking as evidence of inelastic deformations. Evidence of soil liquefaction was also observed over parts of the slab on grade. Depending on the foundation type, liquefied soils can act as a sort of base isolation or as a method to lengthen the period. This generally results in a lower yield acceleration and lower structural demands. As such, it is possible that this parking garage was not subjected to ground motions as severe as those shown in Figure 1, in spite of being only 1.5 kms away from station CCCC in Figure 2. However, because these EBFs were not drift dominated they were designed for the maximum $\mu = 4$ ductility demand. Also these active links were added as finished components into the largely precast concrete structure and so were not tied into the floor slab with shear studs as they were for the taller buildings previously discussed. This meant that they did not have the same strength enhancement due to resistance to out of plane deformation of the floor slab as the taller buildings had.

The fractures, as shown in closeup in Figure 6(c) were of particular concern as these were the first fractures recorded in EBFs worldwide. Further puzzlement was added by the fact that the fracture plane, shown in Figure 6(c), indicated a ductile overload failure rather than a brittle fracture. However, the likely explanation lies in the offset of the brace flange from the stiffener. This offset is shown in Figure 6(c) and means that, when the brace was loaded in tension, the axial tension force in the brace fed into the active link/collector beam panel zone through a flexible beam flange rather than directly into the

stiffener. This meant that the junction between the unstiffened beam flange and the beam web was overloaded, leading to fracture between these two surfaces and this fracture spreading across the beam flange and through the web. Evidence in support of this is from the following:

- where the flanges of the brace line up with the stiffeners, as in the right hand side of the active link shown in Figure 6(b) or the panel zone shown in Figure 6(e), there was no damage to this panel zone region
- the damage to the panel zone region is directly proportional to the eccentricity between the brace flange and the active link end stiffener

Also, the ramp at the top level, built in anticipation of future additional stories, suffered damage as the only EBF on the upper segment of the ramp was located at the east end of that ramp, inducing torsional response and shear failure of the columns in moment-frame action at the west end of the ramp – these shear failures had not been repaired by the time of the aftershock and exhibited more significant damage (temporary lateral bracing were installed to prevent further sway motions). Steel angles, originally added at the expansion joint to meet the design requirement for support length of hollow-core slab prevented unseating of the ramp. The EBF link at the ramp level itself exhibited substantial inelastic distortions.

The lateral bracing of the active links in the building shown in Figure 6 was only in the form of a confining angle each side of the top flange, as shown in Figure 6(d) and 6(e). No lateral movement or twisting of the ends of the active links was observed, indicating that the lateral restraint provisions had been adequate despite only being applied to the top flange and for EBFs not integral with the slab above.

Figure 6: Parking garage on St Asaph St and Antigua St, Christchurch [Photos by M. Bruneau]; (a) Redundancy provided by multiple EBF bays; (b) Evidence of EBF link yielding; (c) Fractured link at lower level EBF; (d) Evidence of inelastic deformations at top level EBF; (e) Close-up view of same; (f) Displacement at expansion joint, top ramp.

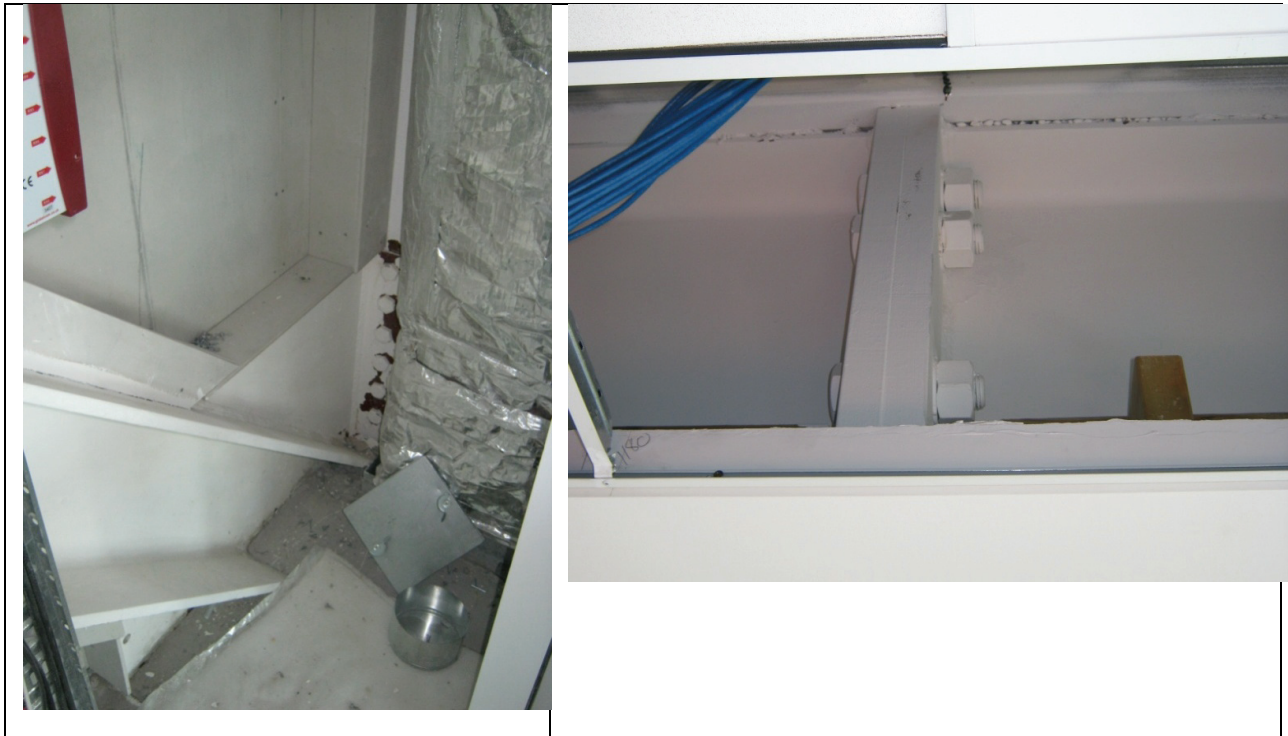
Connections in modern steel frames performed very well and as expected. Figure 7 (a) shows a brace/beam/column connection in which the gusset plate is welded to the beam and bolted to the column with a flexible end-plate connection, which is designed and detailed to be rigid for vertical load transfer and flexible in the horizontal direction, to accommodate change in the angle between beam and column during the earthquake. This flexible end-plate has undergone limited out-of-plane yielding, protecting the gusset plate from inelastic demand. Figure 7 (b) shows a flush endplate splice in a MRF beam that has performed well.

Figure 7: Connections in Club Tower Building, Christchurch [Photos by G C Clifton]; (a) Brace/beam/column connection showing out-of-plane yielding in endplate but no inelastic demand in gusset plate; (b) Flush moment endplate splice connection

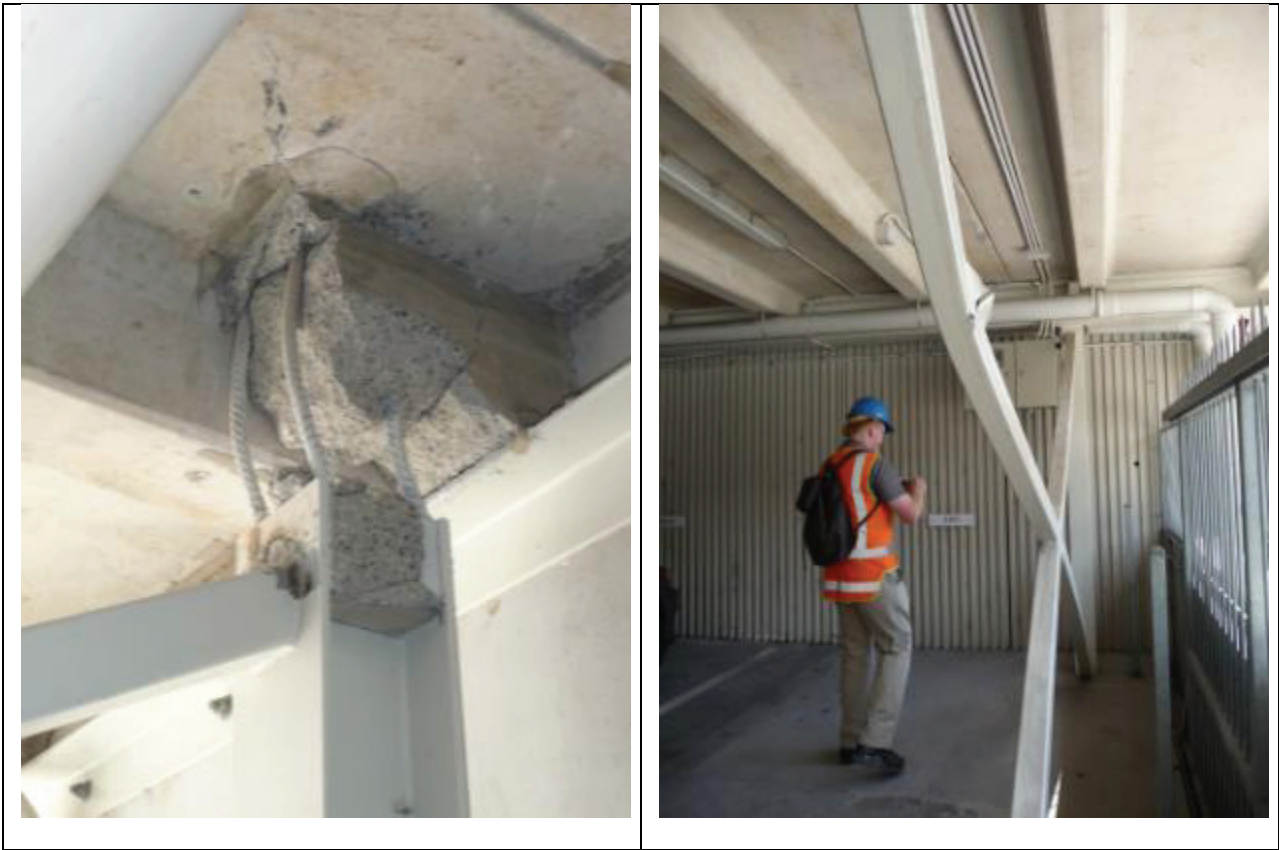
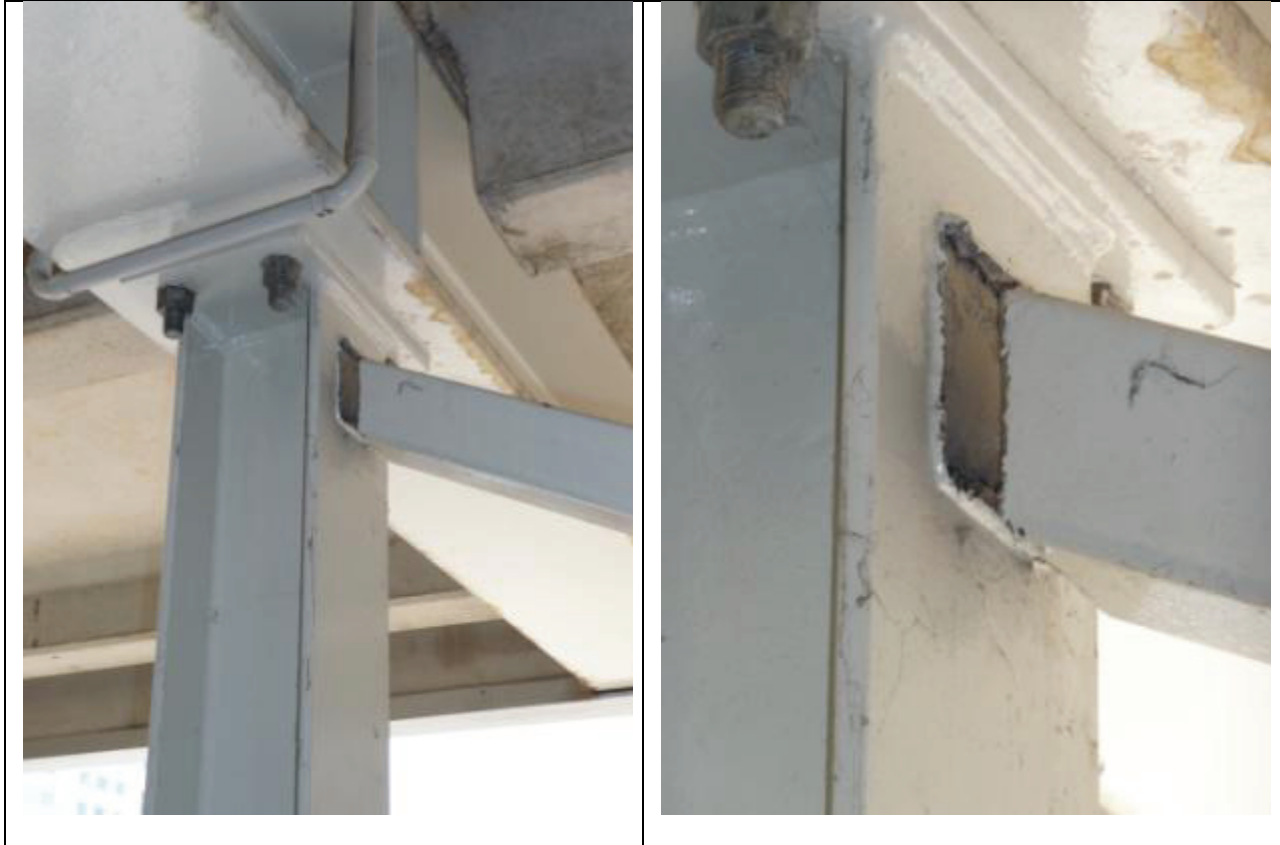
A single suspended level parking garage with concentrically braced frame (CBF) was found to have performed poorly (Figure 8). The garage had solid pre-cast panel walls on three sides, and two individual CBF bays along the fourth side (one bay on each side of the garage door). While the columns of the westernmost CBF tied to a steel beam at their top, the easternmost CBF was not similarly aligned with a steel beam. A non-ductile reinforced concrete extension framing into a concrete beam at the top performed poorly. The other brace of that frame failed at the welds under tension loads; these welds did not appear to be designed to develop the tension capacity of the brace according to the capacity design principles of NZS3404 . The westernmost CBF performed better, without fractures, with visible post-earthquake residual buckling as a consequence of brace elongation.

Figure 8: Low-rise CBF parking garage [Photos by M. Bruneau]: (a) Poor column connection detail; (b) Buckled brace; (c) and (d) Fractured non-ductile brace-to-column connection.

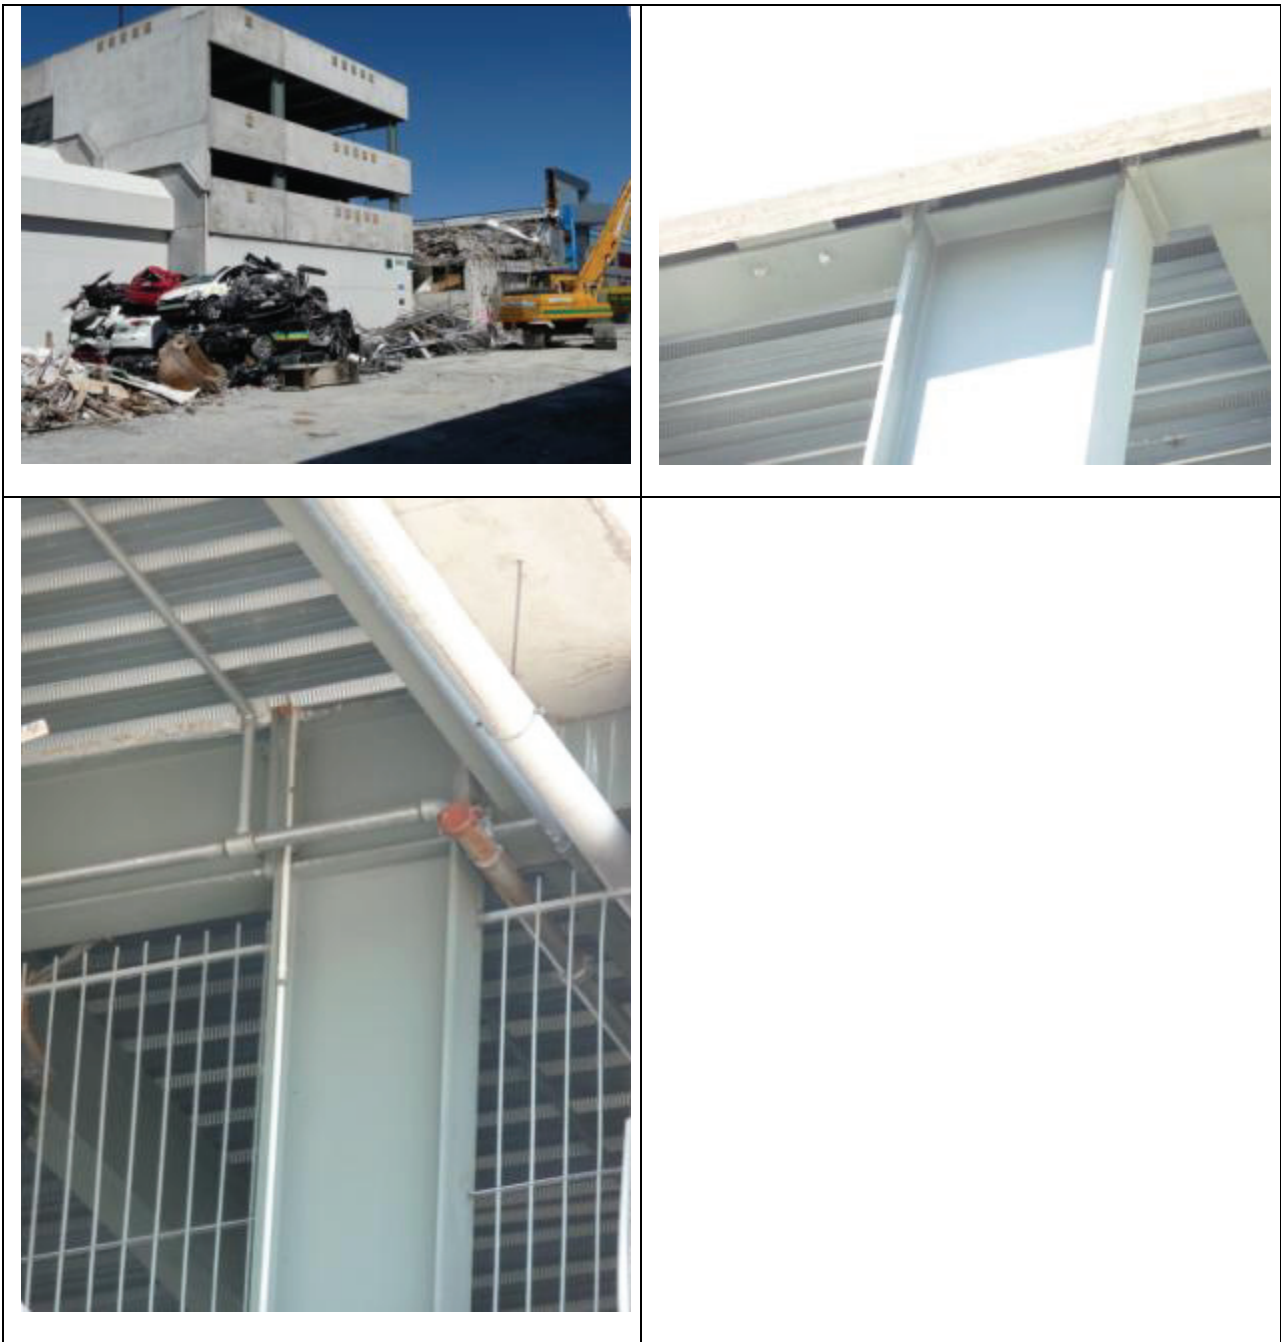
A new parking garage (construction completed after the September 2010 earthquake) appeared to have performed very well, with no visible sign of inelastic deformation at the beam-to-column connections (Figure 9) or in any other part of the structure. However, this assessment could only be done from a distance as a pre-existing post-tensioned concrete section of that garage (together with the spans between the older and newer part of that parking garage) collapsed onto its access ramp.

Figure 9: Low-rise MRF parking garage [Photos by M. Bruneau]: (a) Global view; (b) and (c) Typical moment connections.

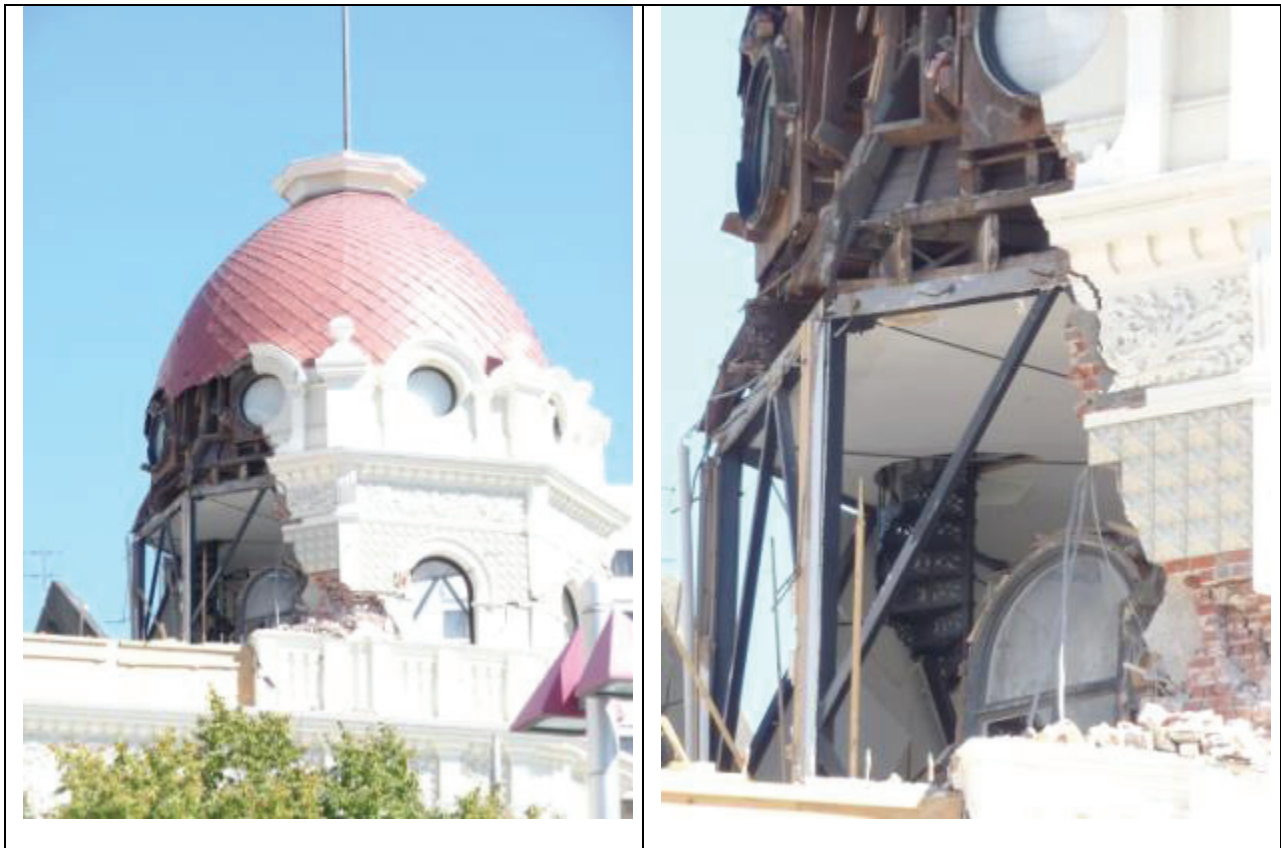
Partial out-of-plane failure around the dome at the top of the Regent Theatre) Building revealed that a braced steel frame had been used there (Figure 10). Although subsequent inspection will be required to verify the integrity of the connections, it appeared to be in good condition from a distance. The building was built before 1910 and the scene was reminiscent of pictures of similar buildings following the 1906 San Francisco earthquake. However, the CBFs appeared to be welded construction (to be verified) which means they are likely to be newer than the rest of the building and had been added in a subsequent retrofit.

Figure 10: Braced dome at top of Regent on Worcester Building [Photos by M. Bruneau]: (a) Global view; (b) Close-up view.

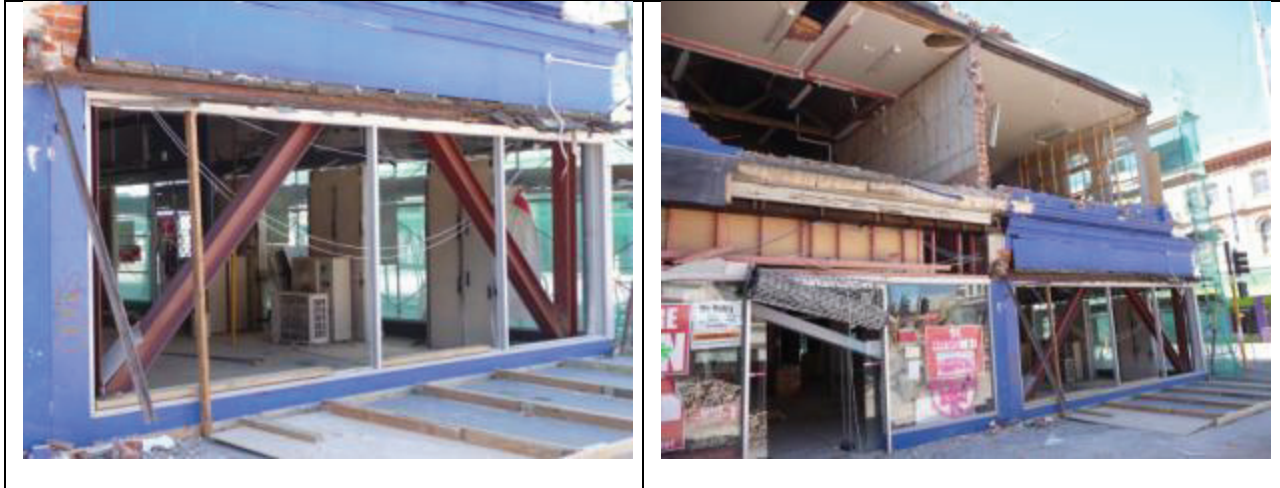
Steel braced frames were sometimes used to retrofit unreinforced masonry structures (e.g. Figure 11). Drift limits to prevent failure of the unreinforced masonry typically govern design in those instances, which explain the significant member sizes of these frames proportional to the reactive mass, and their elastic response.

Figure 11: Braced frame as a retrofit to unreinforced masonry building [Photos by M. Bruneau]: (a) Close-up view; (b) Global view.

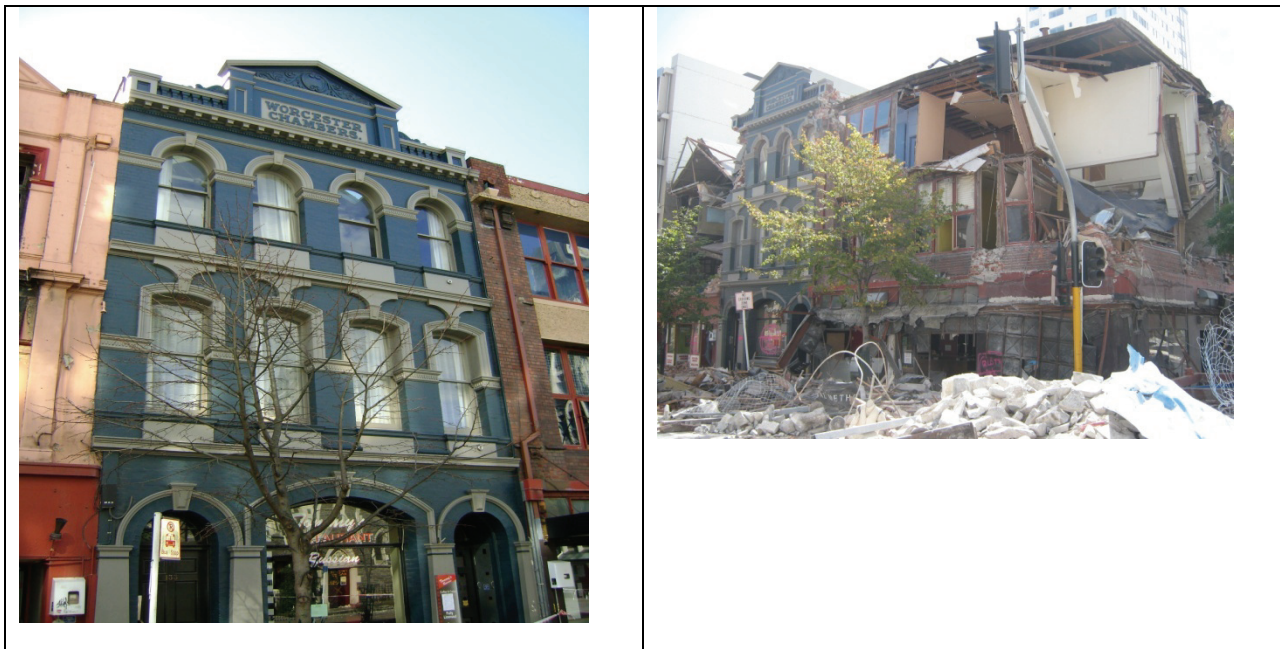
Buildings in the CBD that had been strengthened prior to the September 2010 earthquake typically suffered minimal to no damage in that event. They were not so fortunate in the much stronger February 2011 event. Figure 12 shows one group of three buildings, with (a) showing these following the September 2010 event and (b) showing (from a different vantage point) the three following the February 2010 event. Note especially the strengthened building on the corner has collapsed

Figure 12: Strengthened URM buildings: (a) is following the September 2010 event and (b) following the February 2011 event, taken from a slightly different view-point.

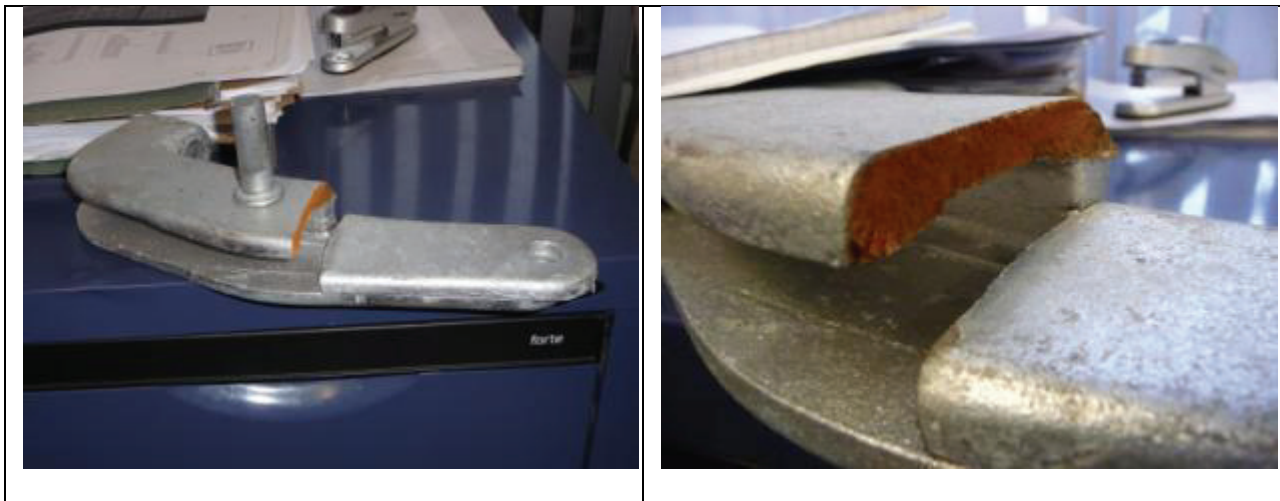
As was the case following the September 2010 Darfield earthquake, a proprietary system often used in these warehouses (sold as a kit) which used a particular banana end fitting, suffered some brittle failures of the cast-steel connectors (as shown in Figure 13). Given that these connectors are rated for earthquake loading based on static tests conducted by the manufacturer, in light of the few fractures reported following the two earthquakes, some engineers have expressed concerns regarding their potential brittleness and believe that their performance needs to be validated under a dynamic test regime more representative of their expected seismic demands, particularly simulating the impact forces applied when previously-buckled braces re-tighten during earthquake excitations.

Figure 13: Example of fractured banana end of proprietary brace connector in the roof plane of a long span steel portal frame building [Photos by M. Bruneau]: (a) Global view; (b) Close-up view.

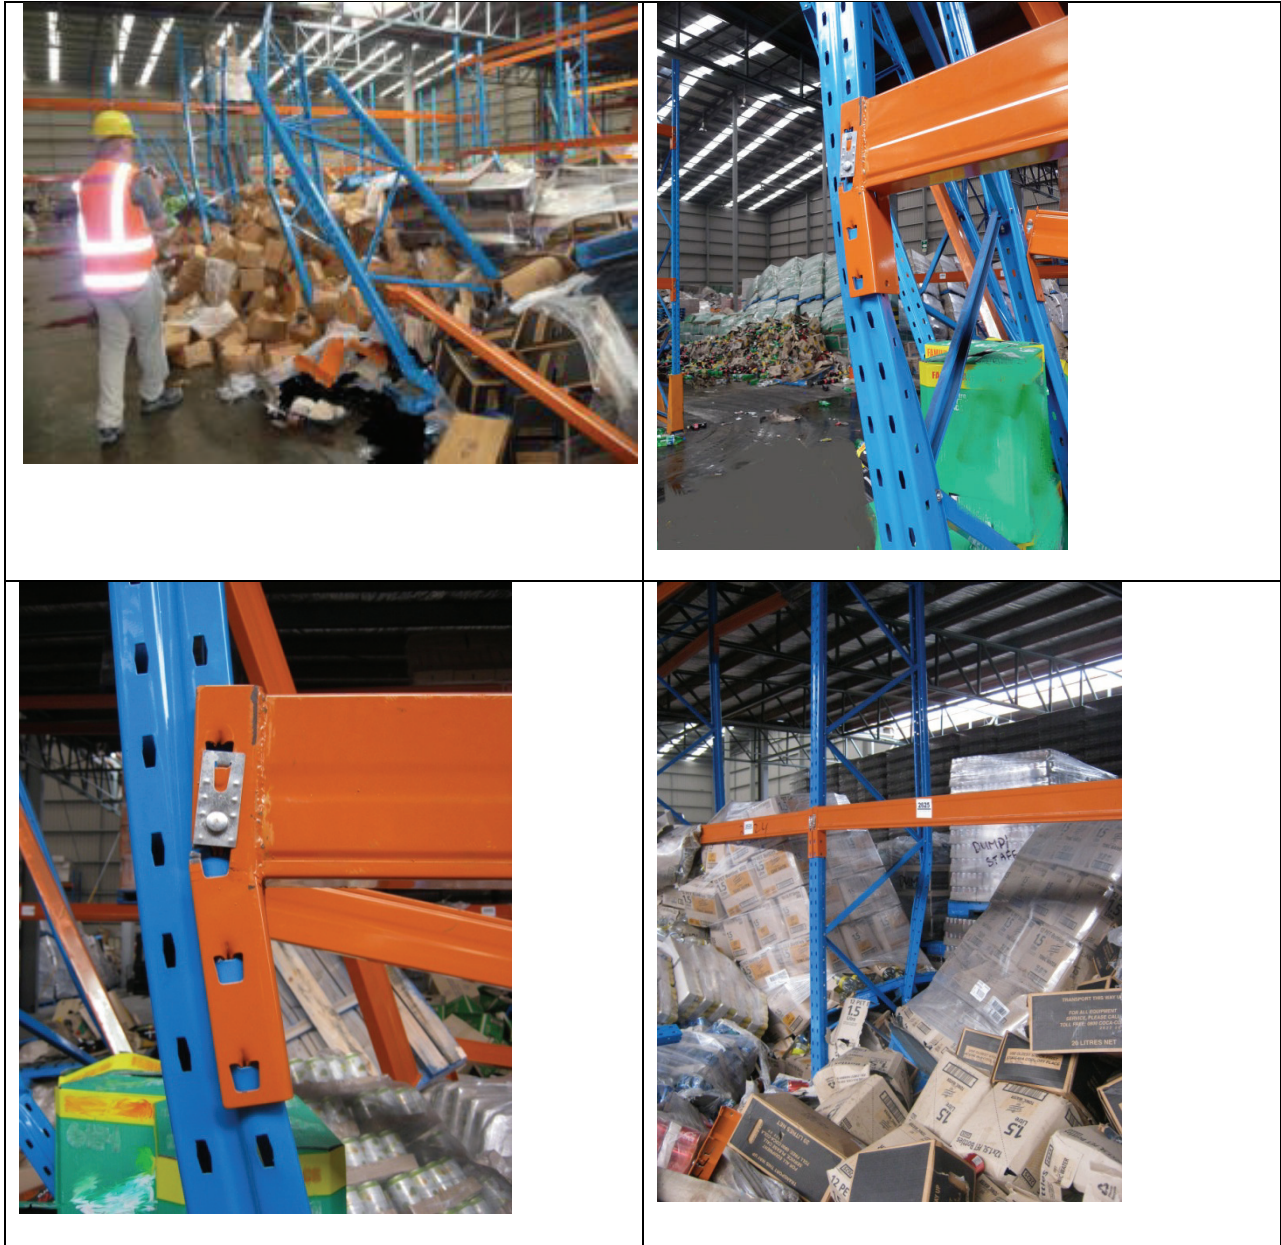
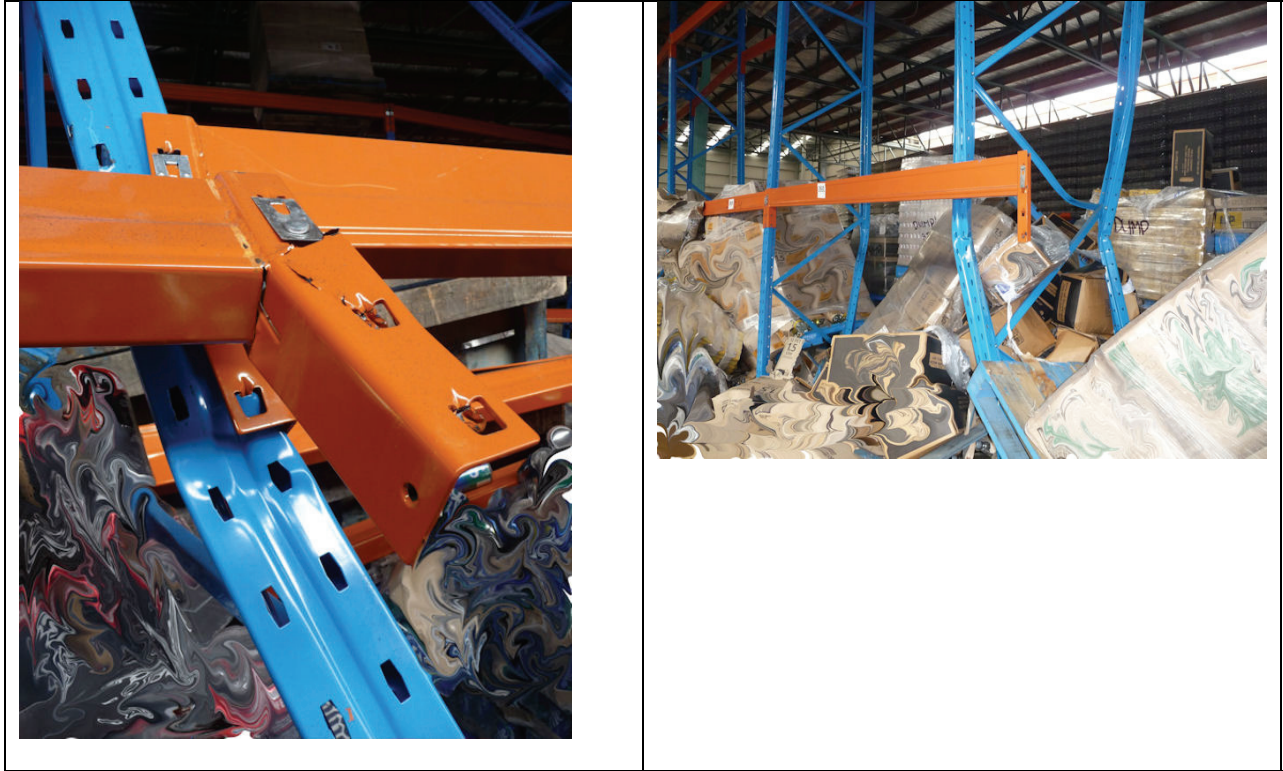
Extensive failure of steel storage racks was observed in industrial facilities, in some cases in spite of additional measures taken following the September earthquake. For example, one facility owner who had racks stacked 6 pallet-levels high that collapsed during the September 2010 earthquake, purchased new racks “designed to resist Magnitude 7 earthquakes of the type expected in [the most active seismic zone of] Wellington” and re-structured his operations to limit stacking to three levels. In spite of those measures, all racks experienced total collapse, as shown in Figure 14. While racks that failed in the transverse direction could have been pushed due to “spilling” of the pallets and piling up of the products

into the aisles, this was not a factor in the longitudinal rack failures that exhibited a combination of overloaded and fractured beam to column connections, and column local buckling. It appeared that the semi-rigid beam to column connections in the longitudinal direction were too weak for the intensity of shaking and design gravity loads.

Figure 14: Example of collapsed industrial storage racks [Photos by M. Bruneau and G C Clifton]:
