STEEL BUILDING DAMAGE FROM THE CHRISTCHURCH EARTHQUAKE OF FEBRUARY 22, 2011, NZST

Michel Bruneau¹, Charles Clifton², Greg MacRae³, Roberto Leon⁴, and Alistair Fussell⁵

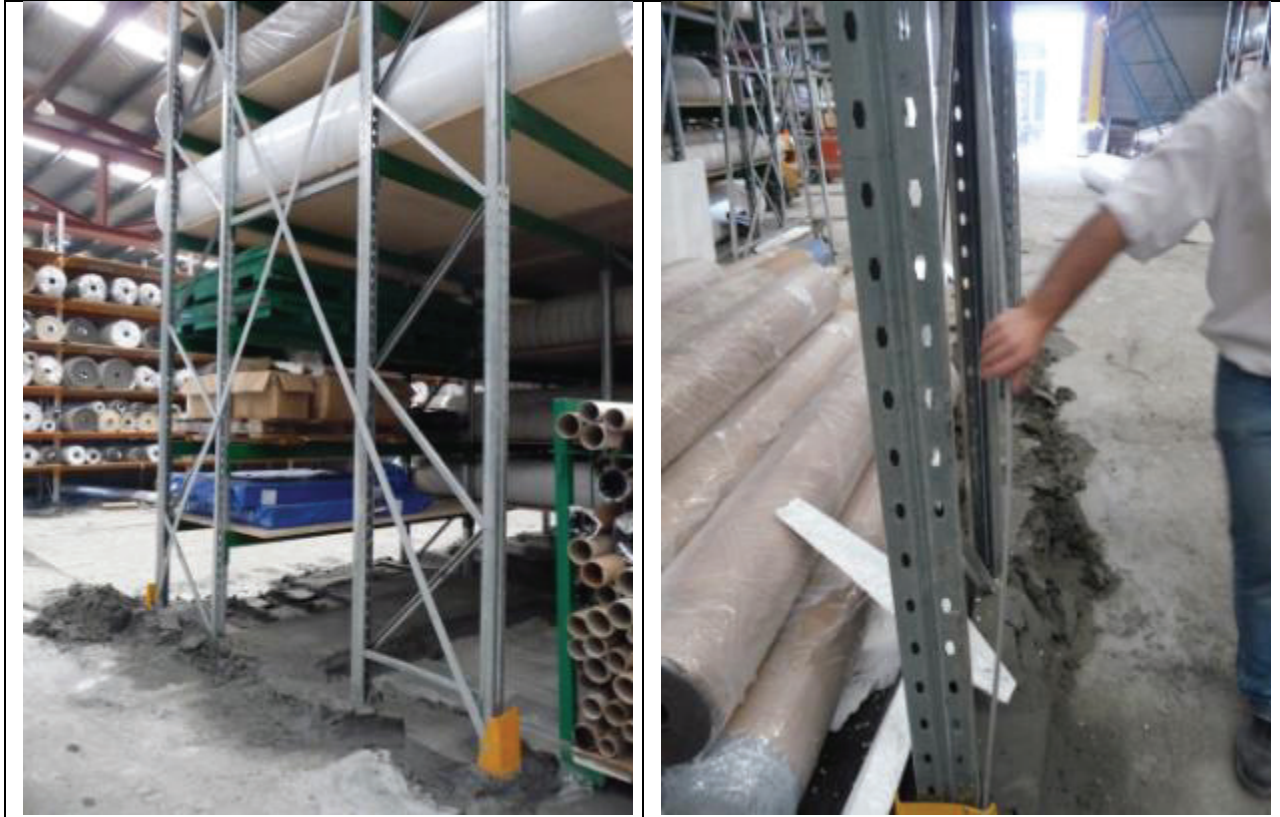
Anecdotally, in another facility, existing racks had been retrofitted by coupling two racks back-to-back with flat bar braces (Figure 15). These bars showed evidence of elongation and residual buckling, but did not collapse, in spite of floor movements due to liquefaction, whereas the only rack that was not retrofitted (for it was not adjacent to a second rack to which it could have been tied) collapsed. The racks has also been allegedly tied to the rafters to prevent longitudinal failures, but such ties could not be identified.

Figure 15: Industrial storage racks that survived, with evidence of soil liquefaction [Photos by M. Bruneau]; (a) Global view; (b) Close –up of buckled brace.

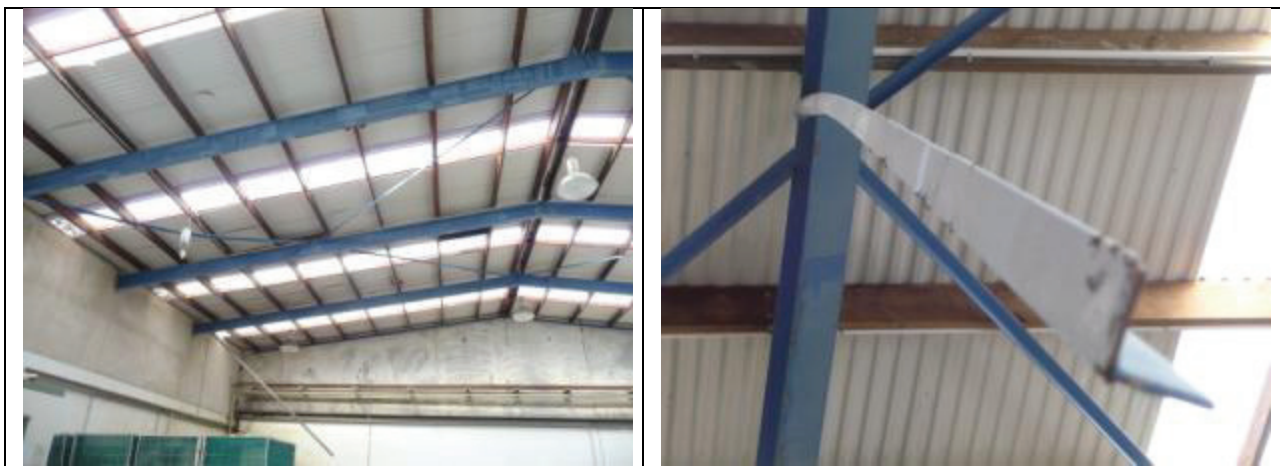
Multiple examples of tilt-up panel movements due to ground liquefaction were observed, sometimes leading to fracture of non-ductile braces unable to accommodate the imposed deformations. One such example is shown in Figure 16, showing a fractured brace and its counterpart buckled brace.

Figure 16: Industrial facility roof bracing [Photos by M. Bruneau]; (a) Global view, showing buckled brace and fractured brace; (b) Close –up view of fractures weld of tension brace.

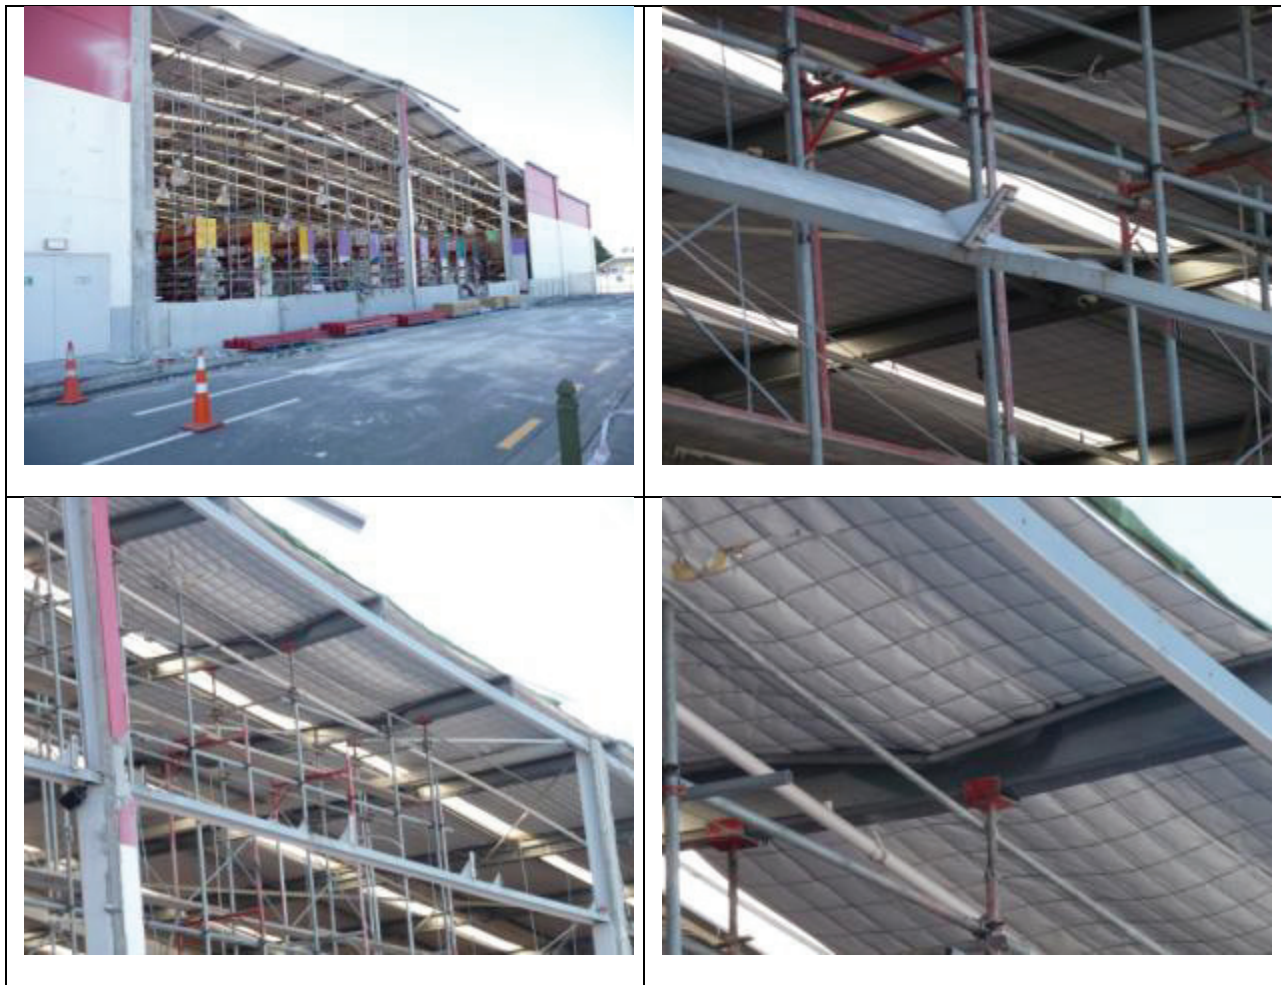
Anchorage of tilt-up walls to steel structures also failed in a few instances. Figure 17 shows roof beams buckled in compression by the inward movement of the tilt-up panels, and failure of the anchors due to their outward movement (i.e. away from the building). Given that this happened in modern construction, and because tilt-up walls of greater slenderness have progressively been implemented in New Zealand, a careful re-assessment of their seismic design provisions may be desirable.

Figure 17 : Failure of tilt-up panel connections [Photos by M. Bruneau]; (a) Global view; (b) Close –up view of fractures connection; (c) Global view of buckled beams; (d) Local view of one such beam.

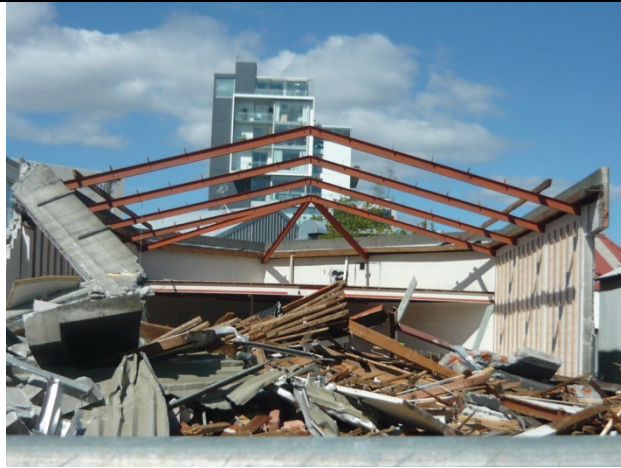
Figure 18 shows the steel structure standing when the roofing has collapsed. This shows remarkable performance of the steel members, but poor performance of the roofing/connections.

Figure 18 : Failure of roof and walls in older industrial facility on Salisbury Street [Photos by MacRae];

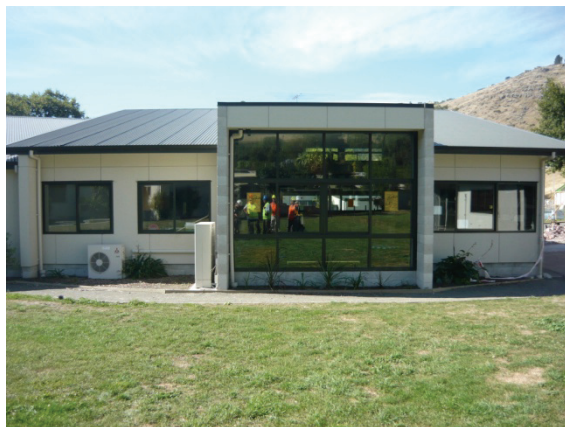
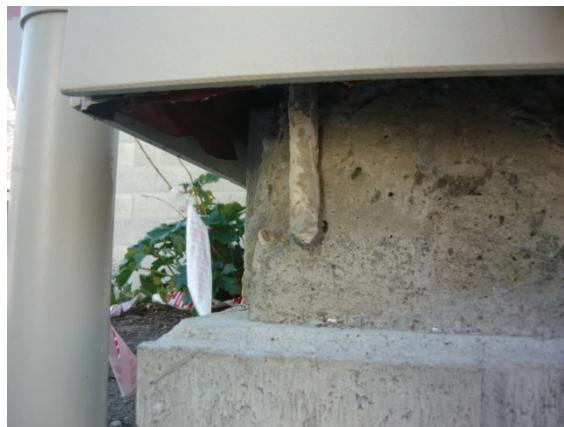
At Heathcote Valley Primary School some of the most extreme shaking during the event was recorded. There was one new single storey building with a steel moment frame and block walls as shown in Figure 19a . After the earthquake the wall was leaning to the east at the southern end, and to the west at the northern end. The concrete baseplate was blown out on the southeast side of the building as shown in Figure 19b.

(a) Overall View from the South (b) Baseplate bolt at SE corner of the building
Figure 19. Heathcote Valley Primary School Steel Moment Frame building (Photos: MacRae)

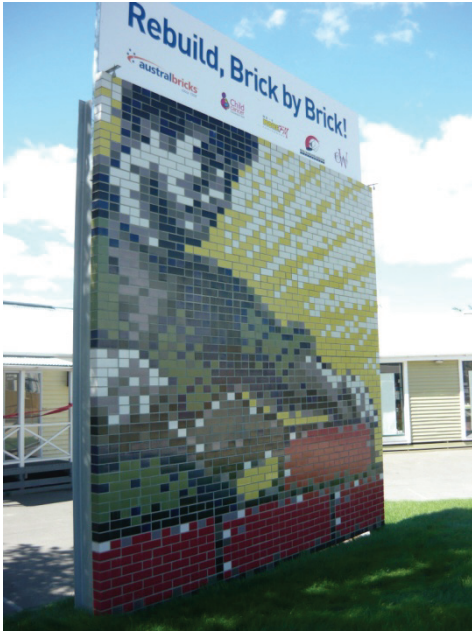
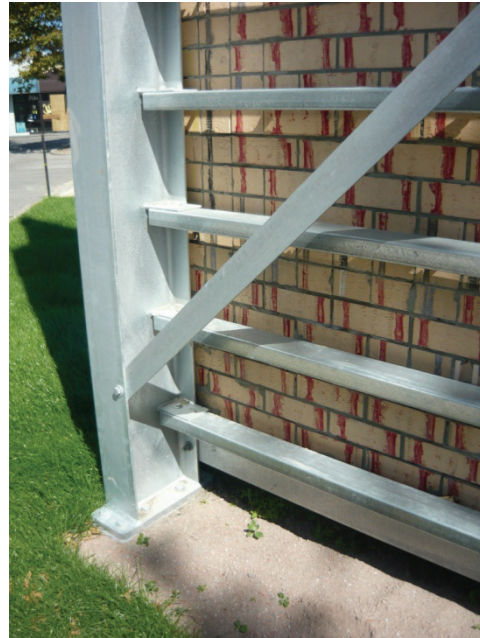
A steel framed wall with a brick façade was erected in a small park as shown in Figure 20, in a part of town that where significant overall structural damage occurred. The wall was placed there after the September 2010 earthquake as states “Rebuild, Brick by Brick”. The wall suffered no damage during this earthquake.

Figure 20. September 2010 Rebuilding Stand Consisting of Bricks Supported by Steel Frame (Photos: MacRae)

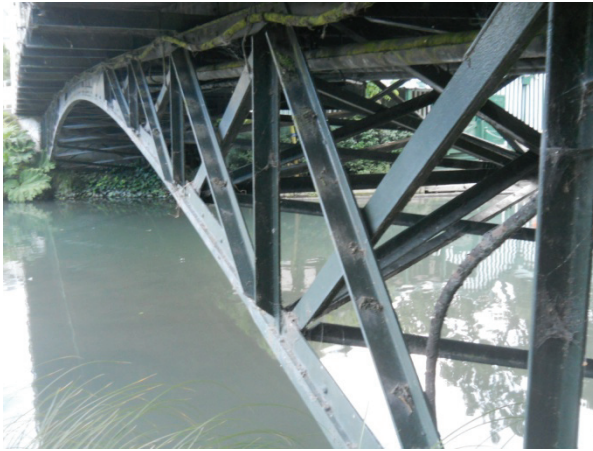
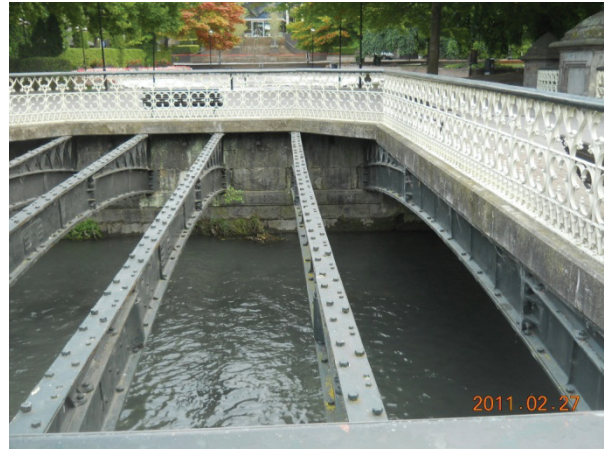
There are relatively few steel bridges in the Christchurch area. A pedestrian arch bridge at the Antigua Boatsheds and one at Victoria Square showed no visible damage (Figure 21).

Figure 21 – Undamaged older steel pedestrian bridges on the Avon River near the CBD (Leon)

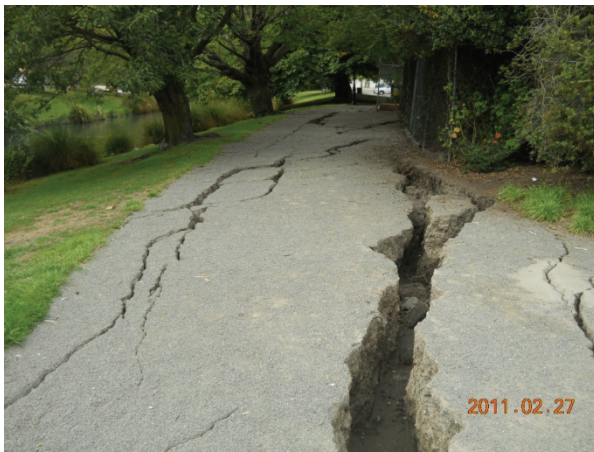
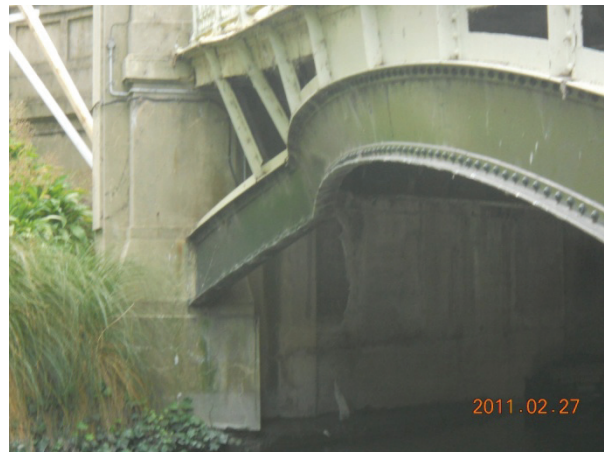
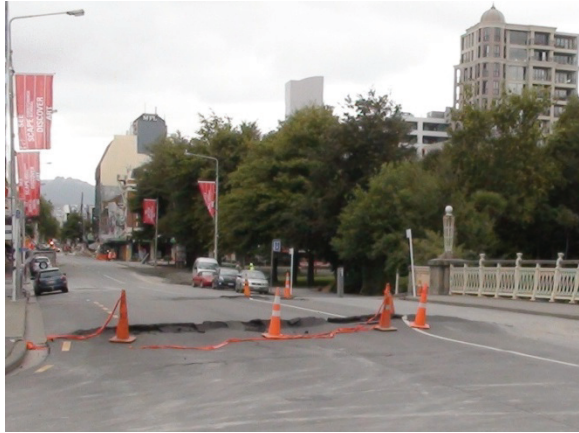
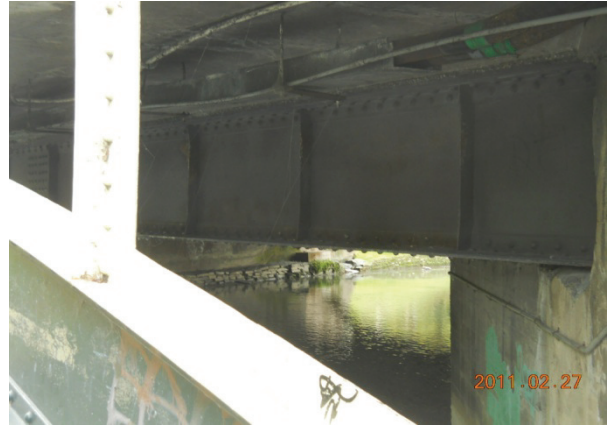
Although substantial liquefaction occurred along the Avon River near the CBD, the only older steel bridge in this area only showed spectacular buckling of its fascia arches; the actual bridge, supported on straight riveted girders appeared undamaged even though large settlements had occurred at the abutments (Figure 22). The old rail bridge over the Waimakariri river behaved well even though it was clear that the pier had moved over 100mm toward the river and back during this shake (Figure 23a). The old road bridge suffered some longitudinal buckling of the lower flange of one beam (Figure 23b) as well as some spalling of concrete on the west side of the abutment. The only major modern steel bridge at the Port of Lyttleton, a three-span continuous plate girder, had only minor damage at the abutment (Figure 24).

Figure 22 – Colombo Street bridge (a) Slumping of riverbank close to bridge; (b) Buckling of fascia arches; (c) Slumping of abutments at end of bridge; (d) Undamaged straight riveted girders. (Leon)

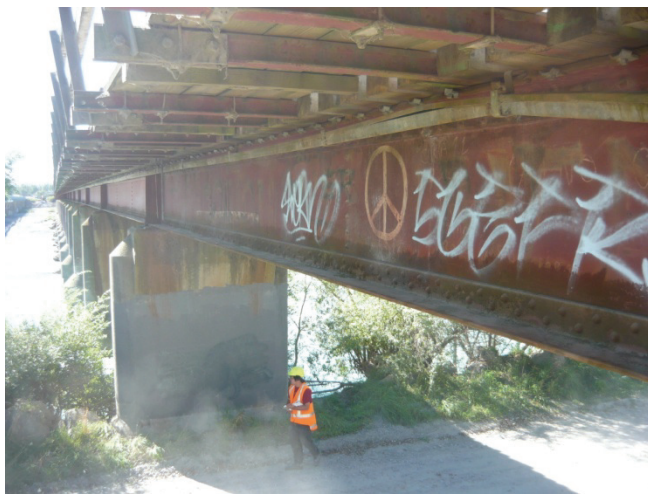
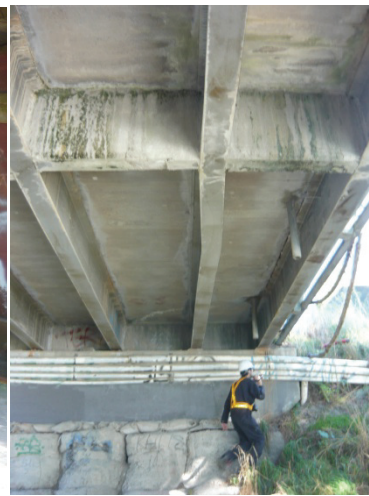
Figure 23 – Waimakariri Bridges, South end (a) Old Rail Bridge, (b) Old road bridge (MacRae)

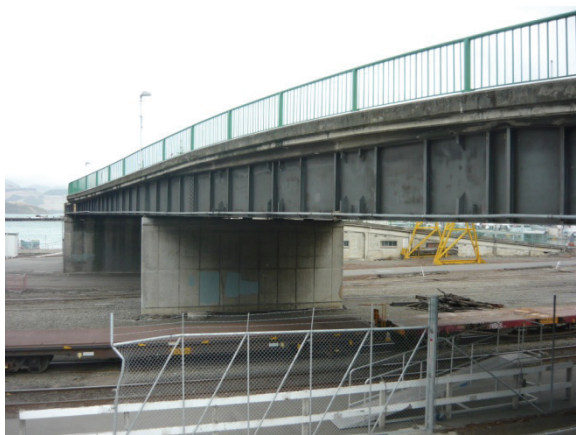
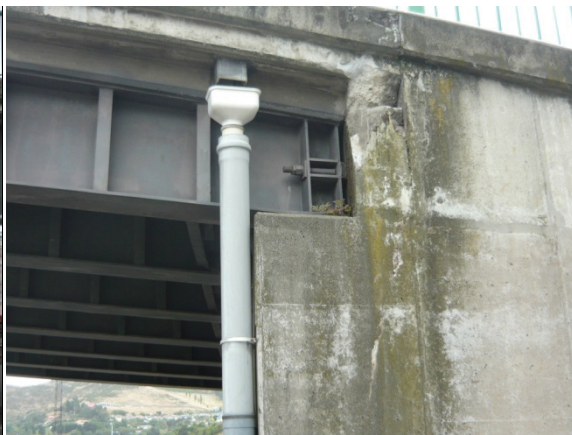
Figure 24 – Lyttleton Port Bridge (a) Plate Girder (b) Abutment Spalling (MacRae)

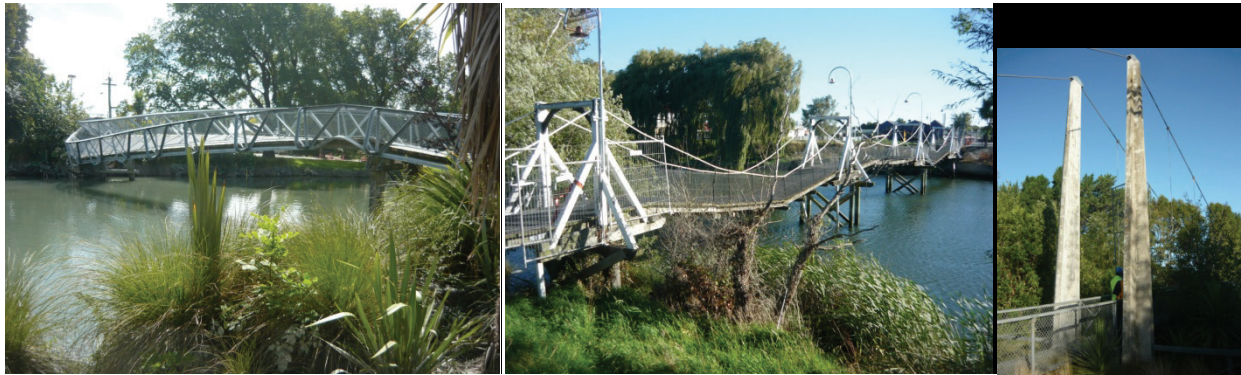
The following footbridges were damaged in the September 2010 earthquake and had not been repaired. Due to further lateral spreading and slumping of abutments, they were even more damaged in this shaking.

Figure 25 – Footbridges (a) Truss bridge over Avon River, (b) Suspension bridge with timber deck Over Kaiapoi river, (c) Suspension bridge at Groynes (MacRae)
