WOOD-FRAME CONSTRUCTION

MASONRY CONSTRUCTION

Postearthquake Safety Evaluation of Buildings

ATC-20

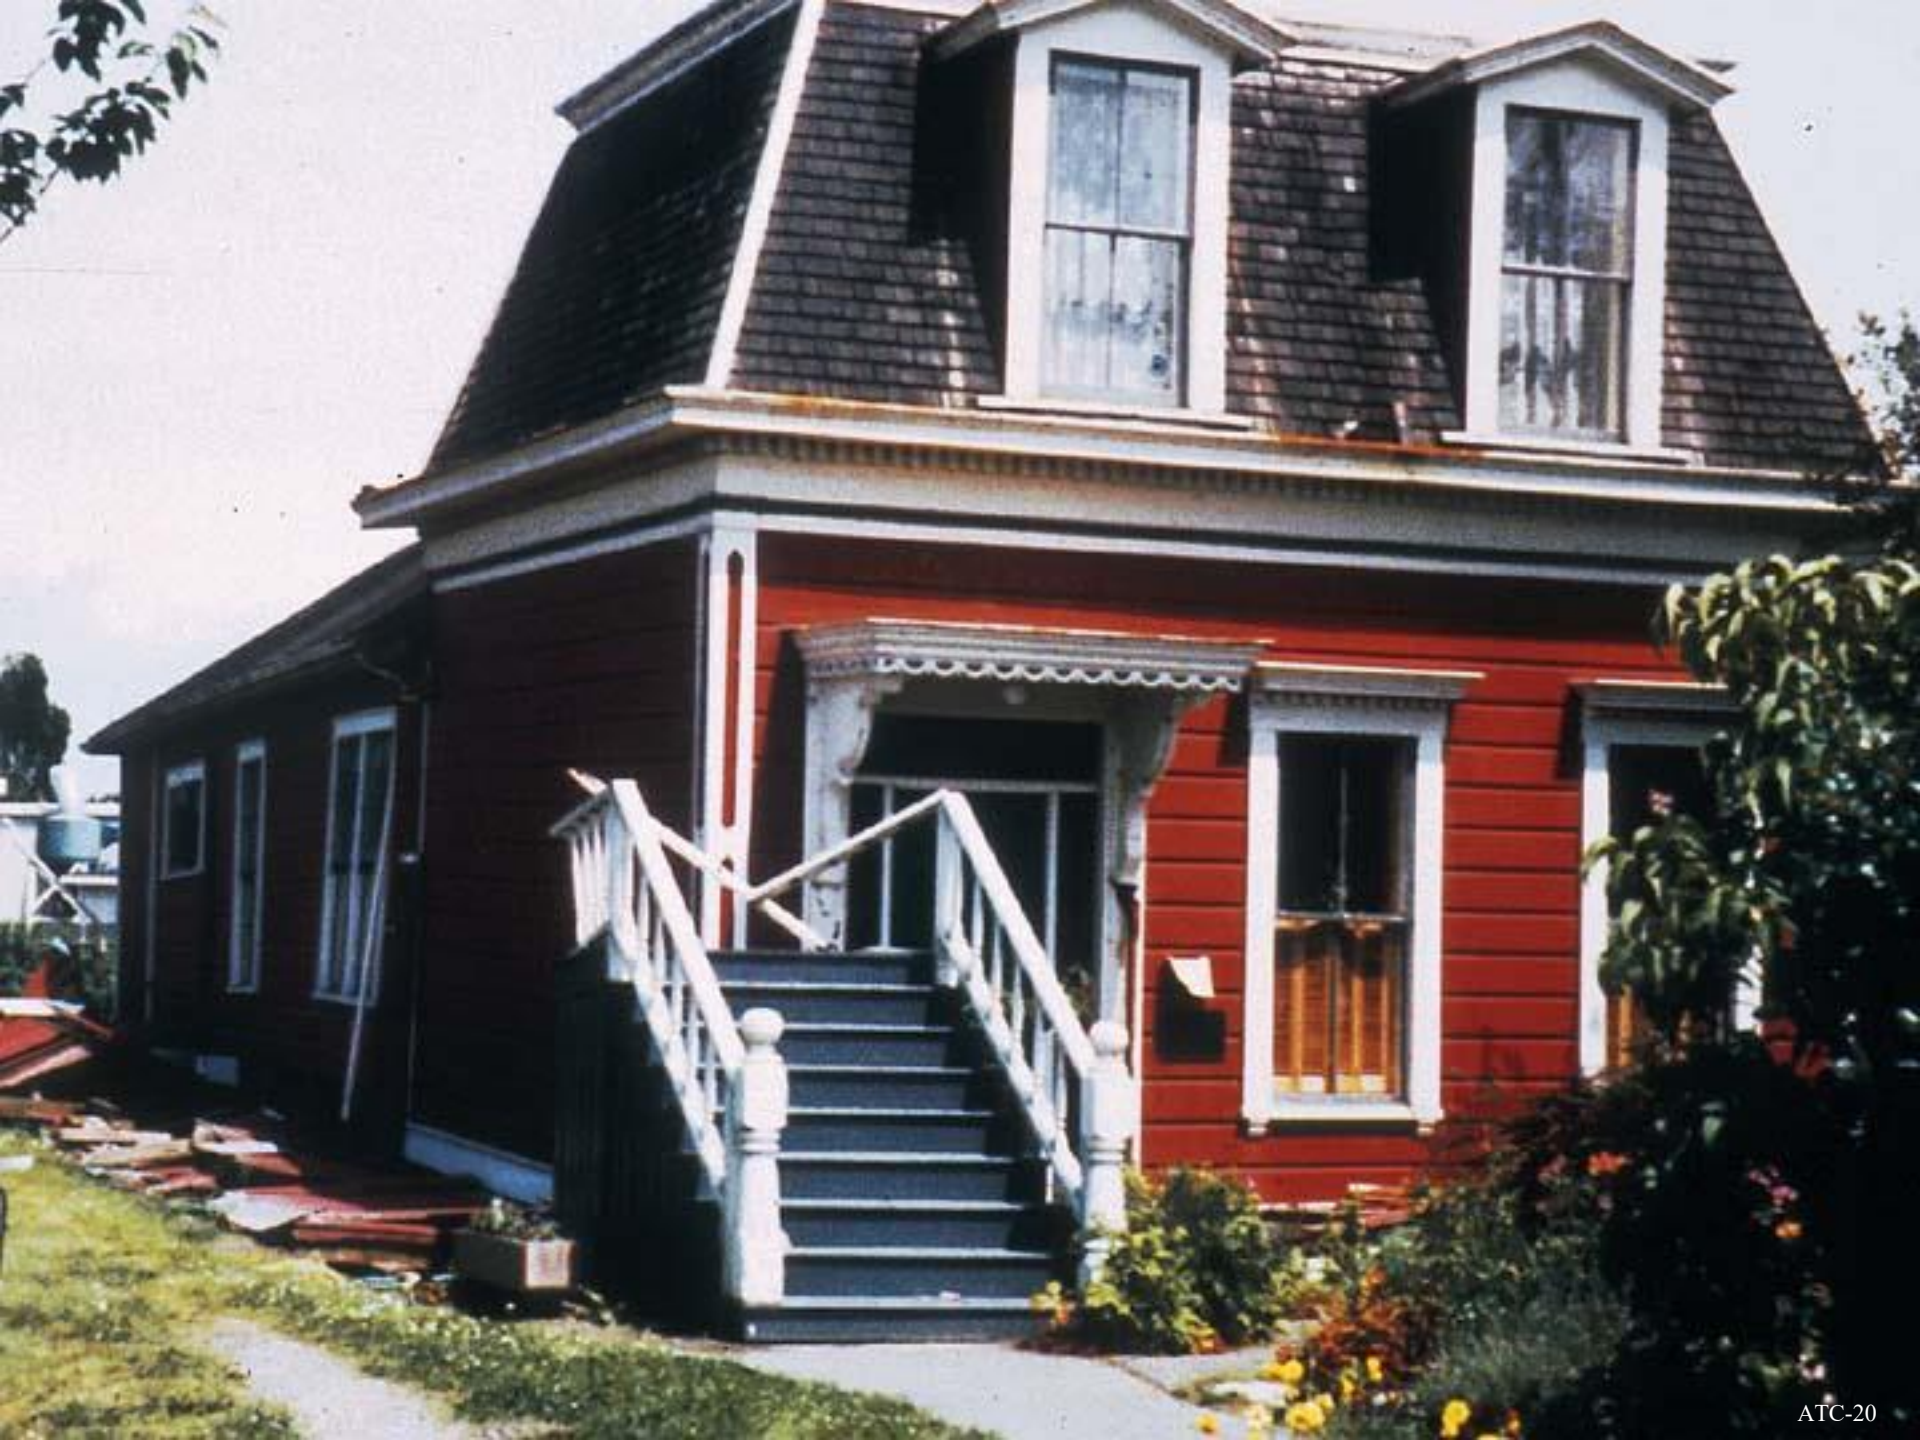
**RACKING OF UNFINISHED
LOWER LEVEL**

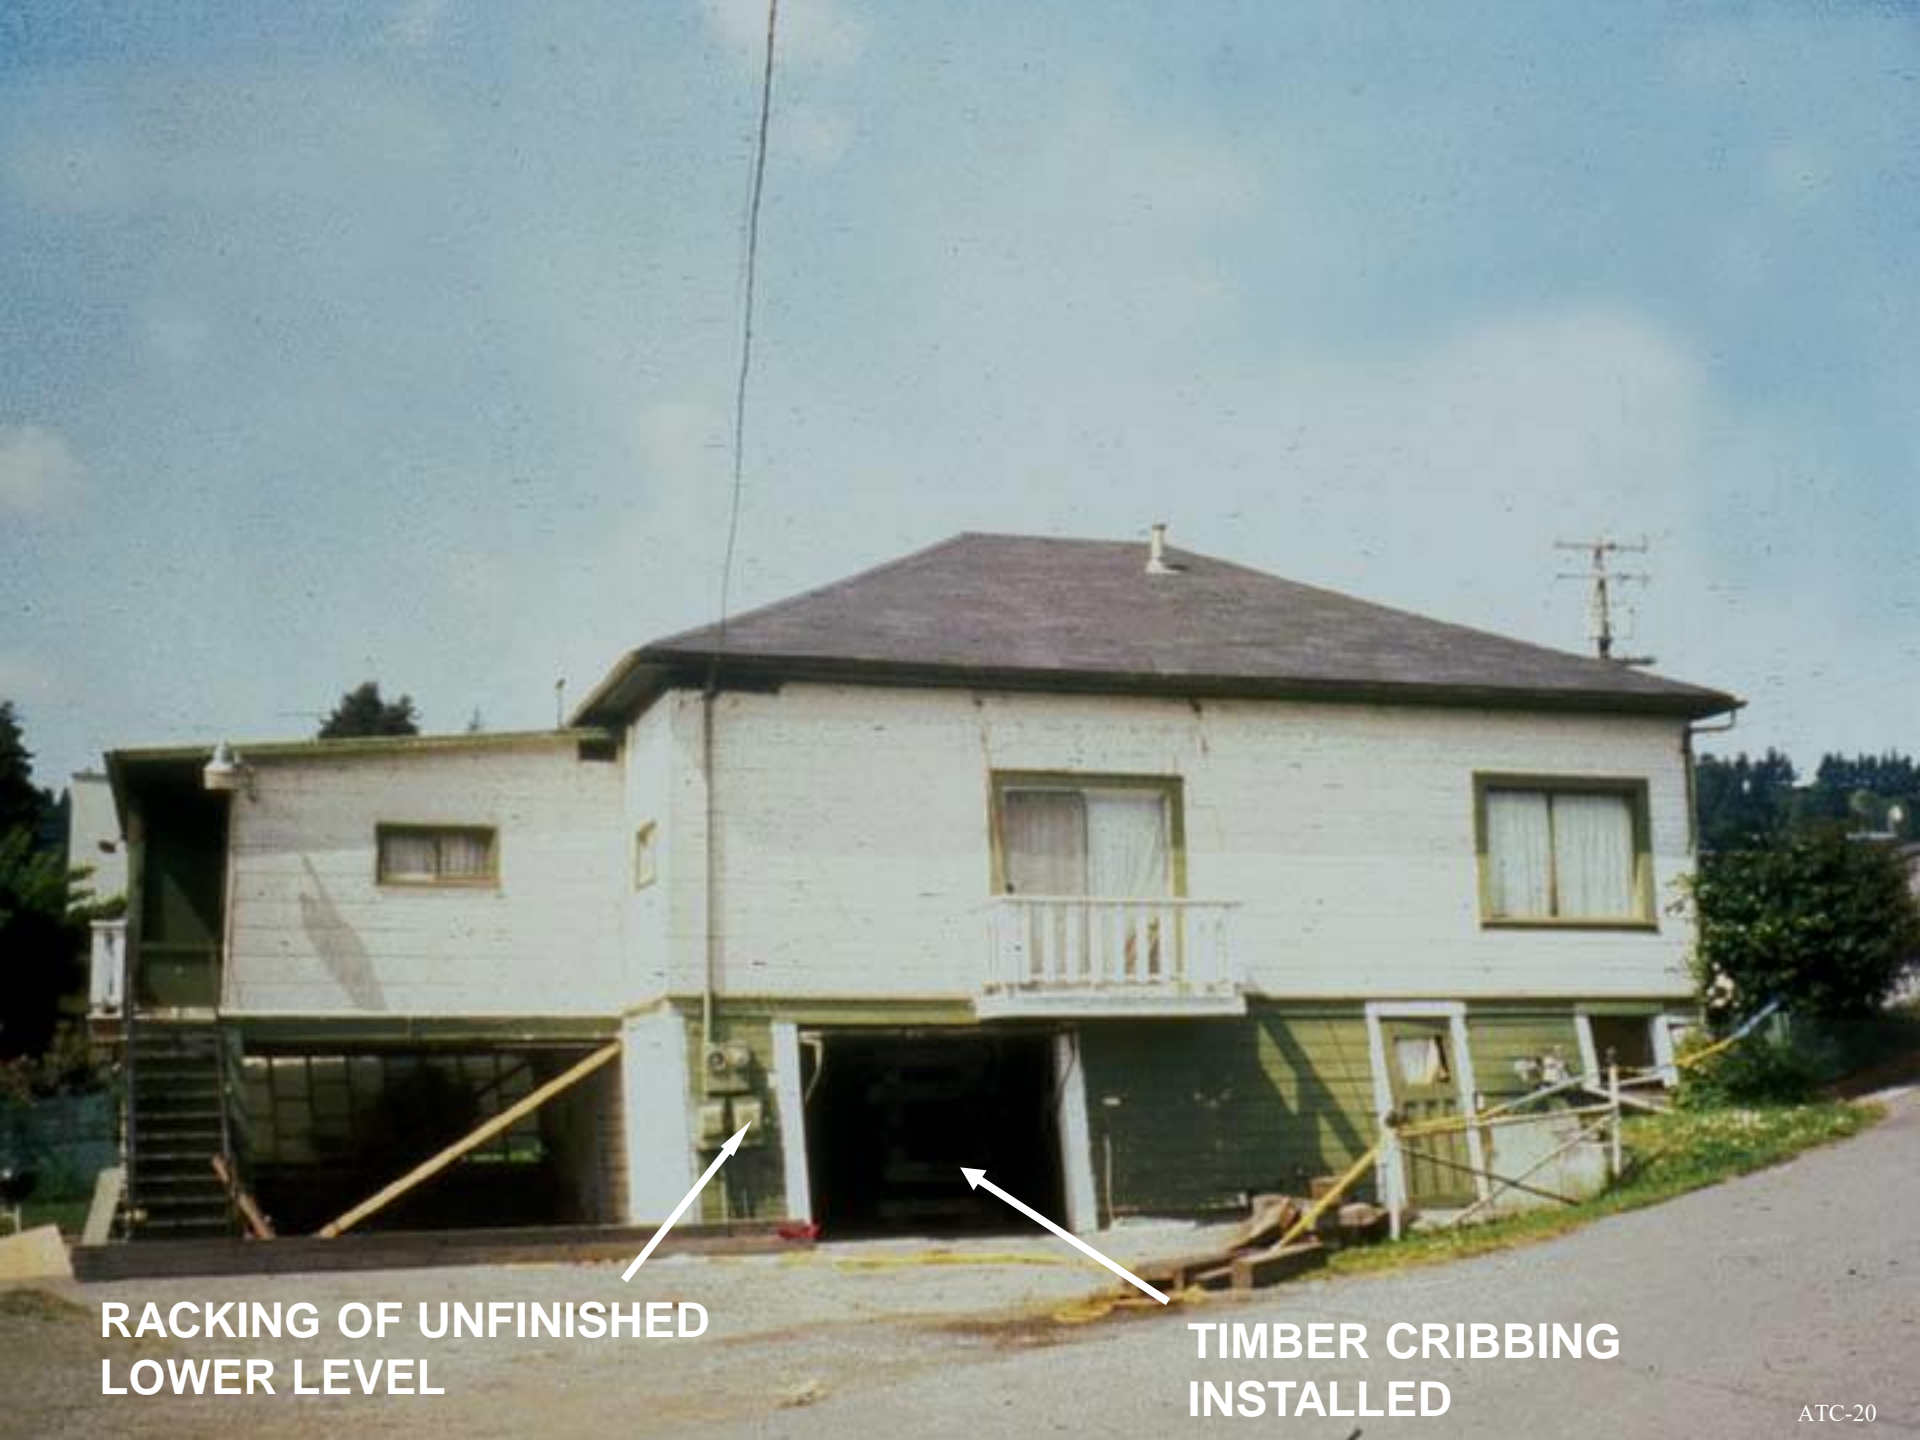
**TIMBER CRIBBING
INSTALLED**

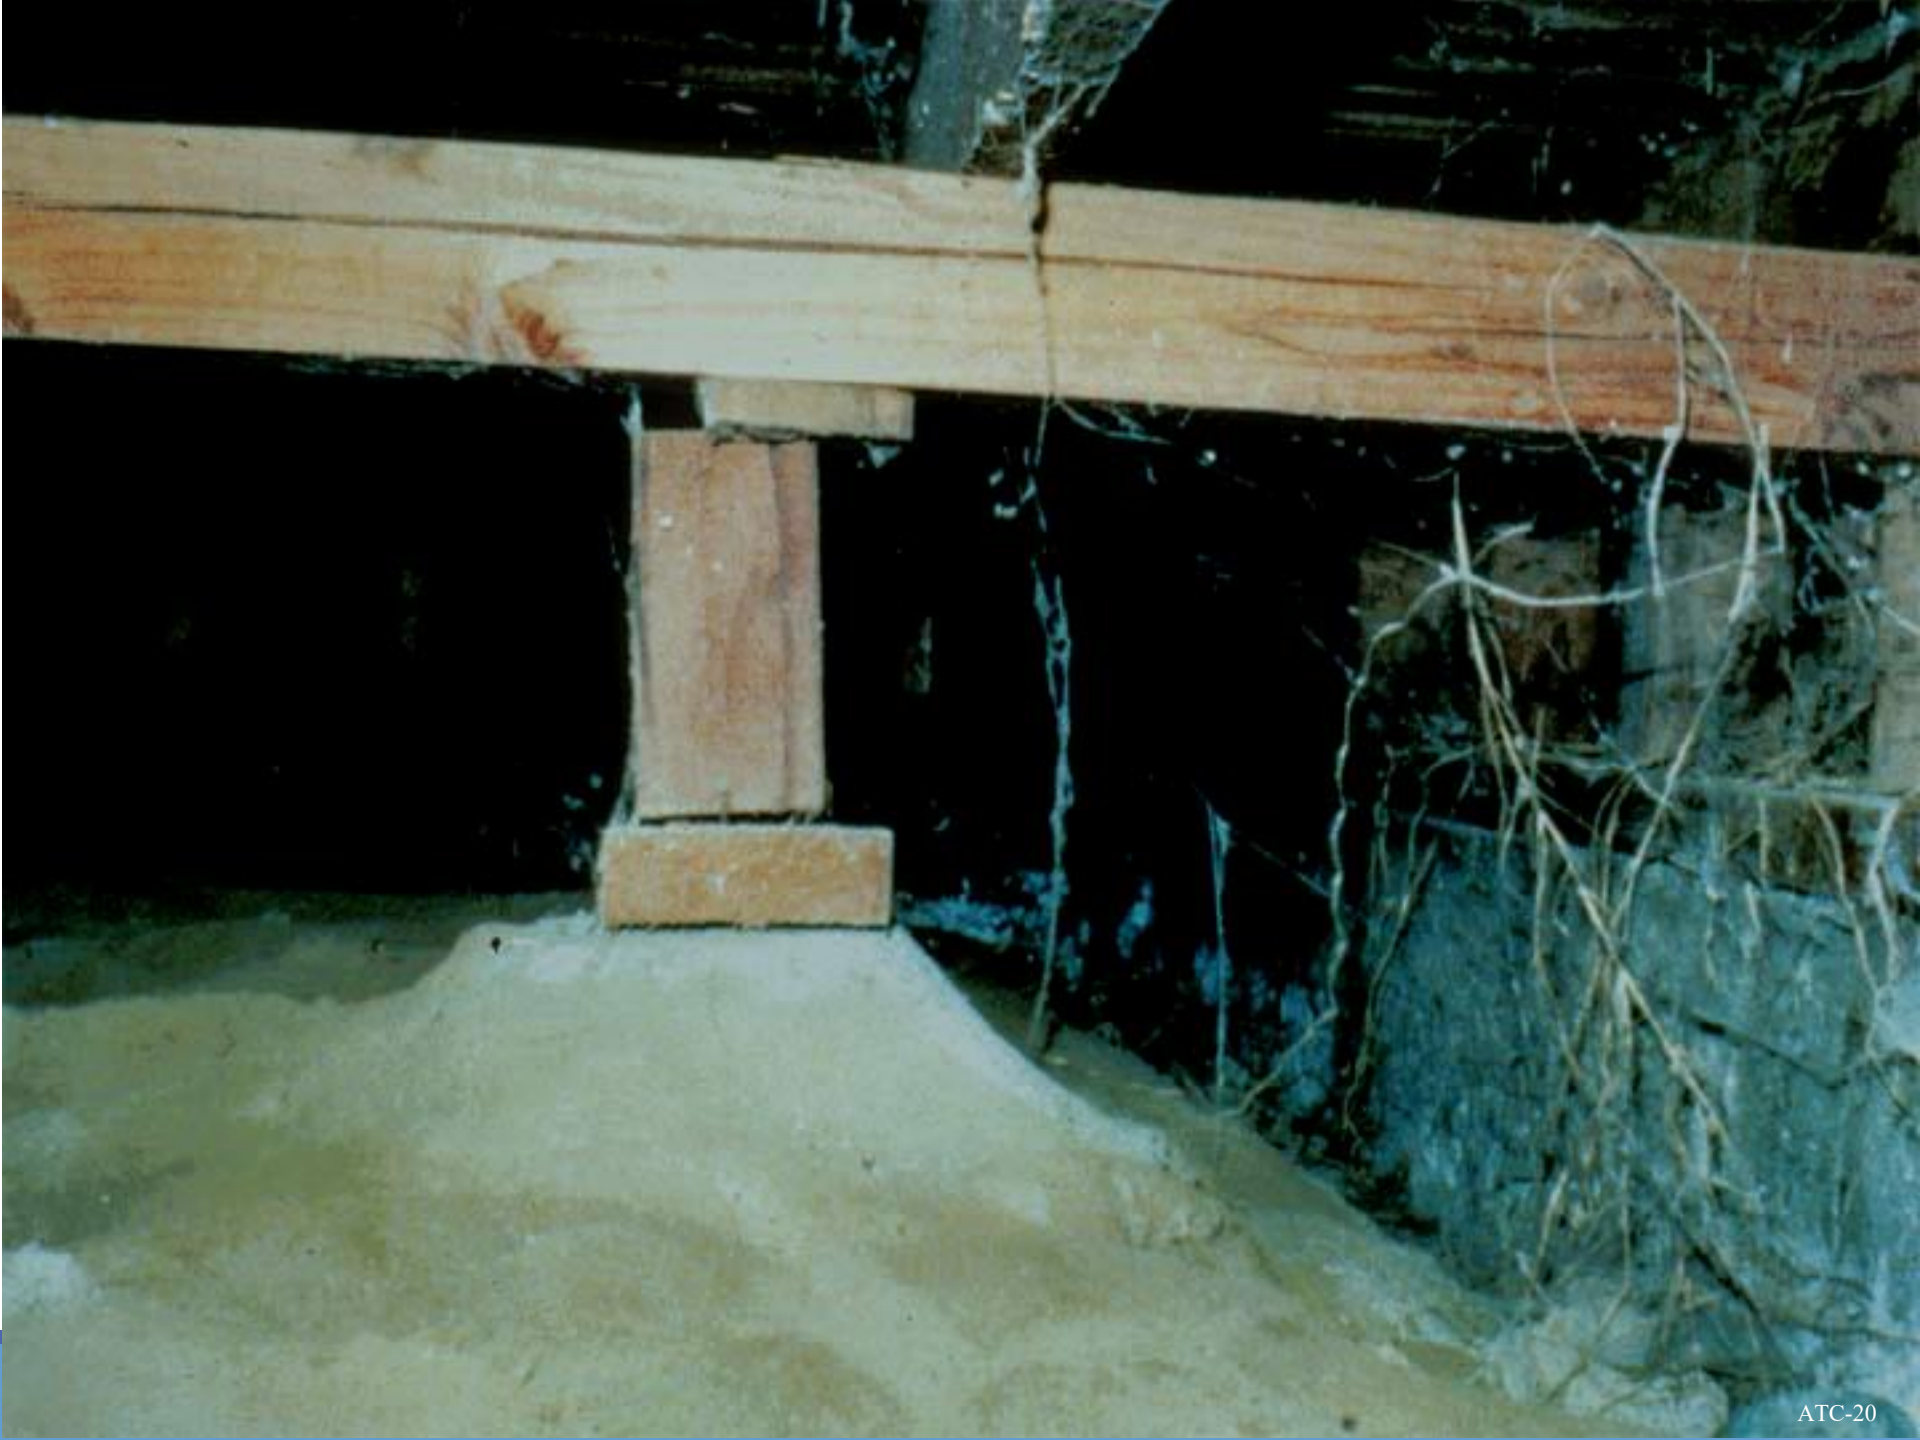
**WOOD
SUPERSTRUCTURE
SLIDING ON
FOUNDATION**

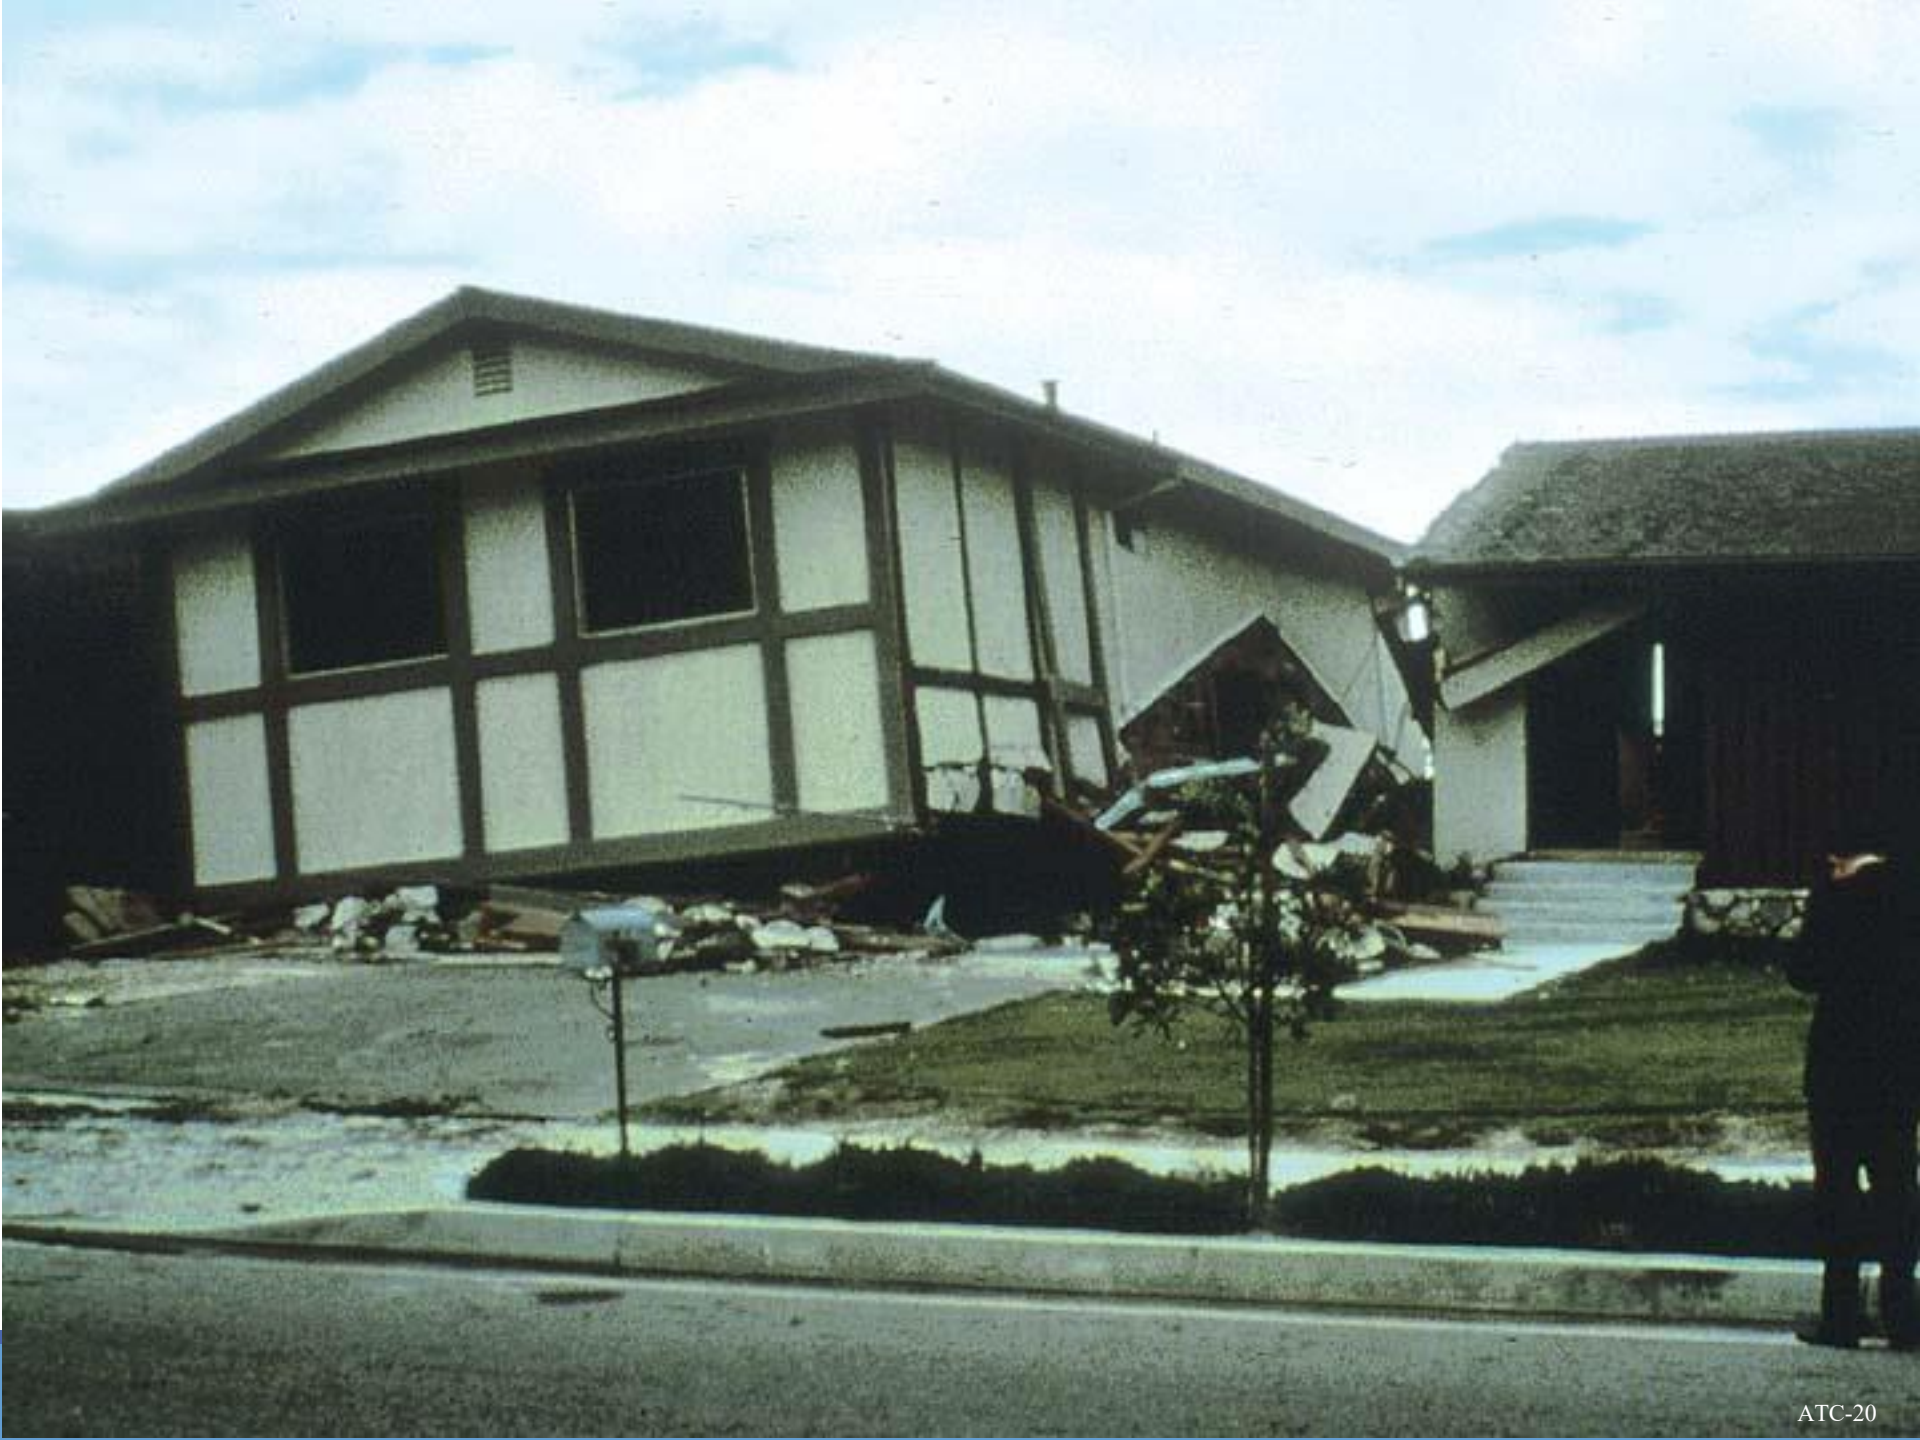
**FAILURE OF
UNREINFORCED
CHIMNEY**

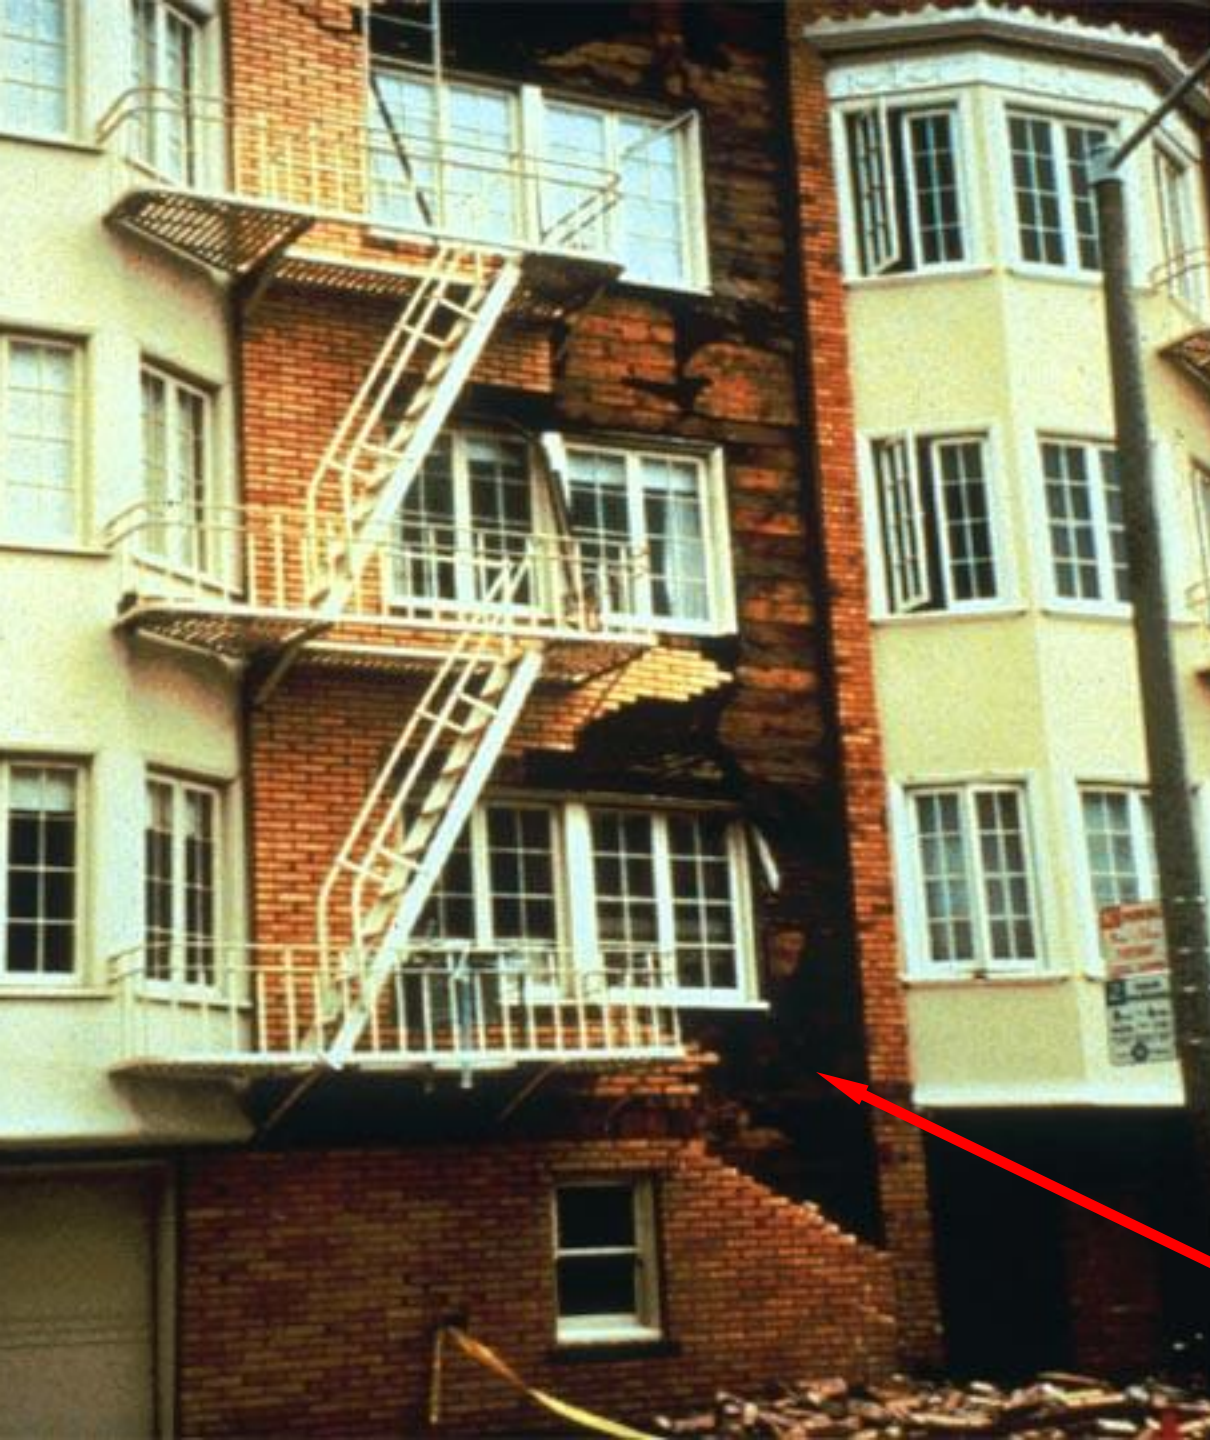
**FAILURE OF BRICK
VENEER**

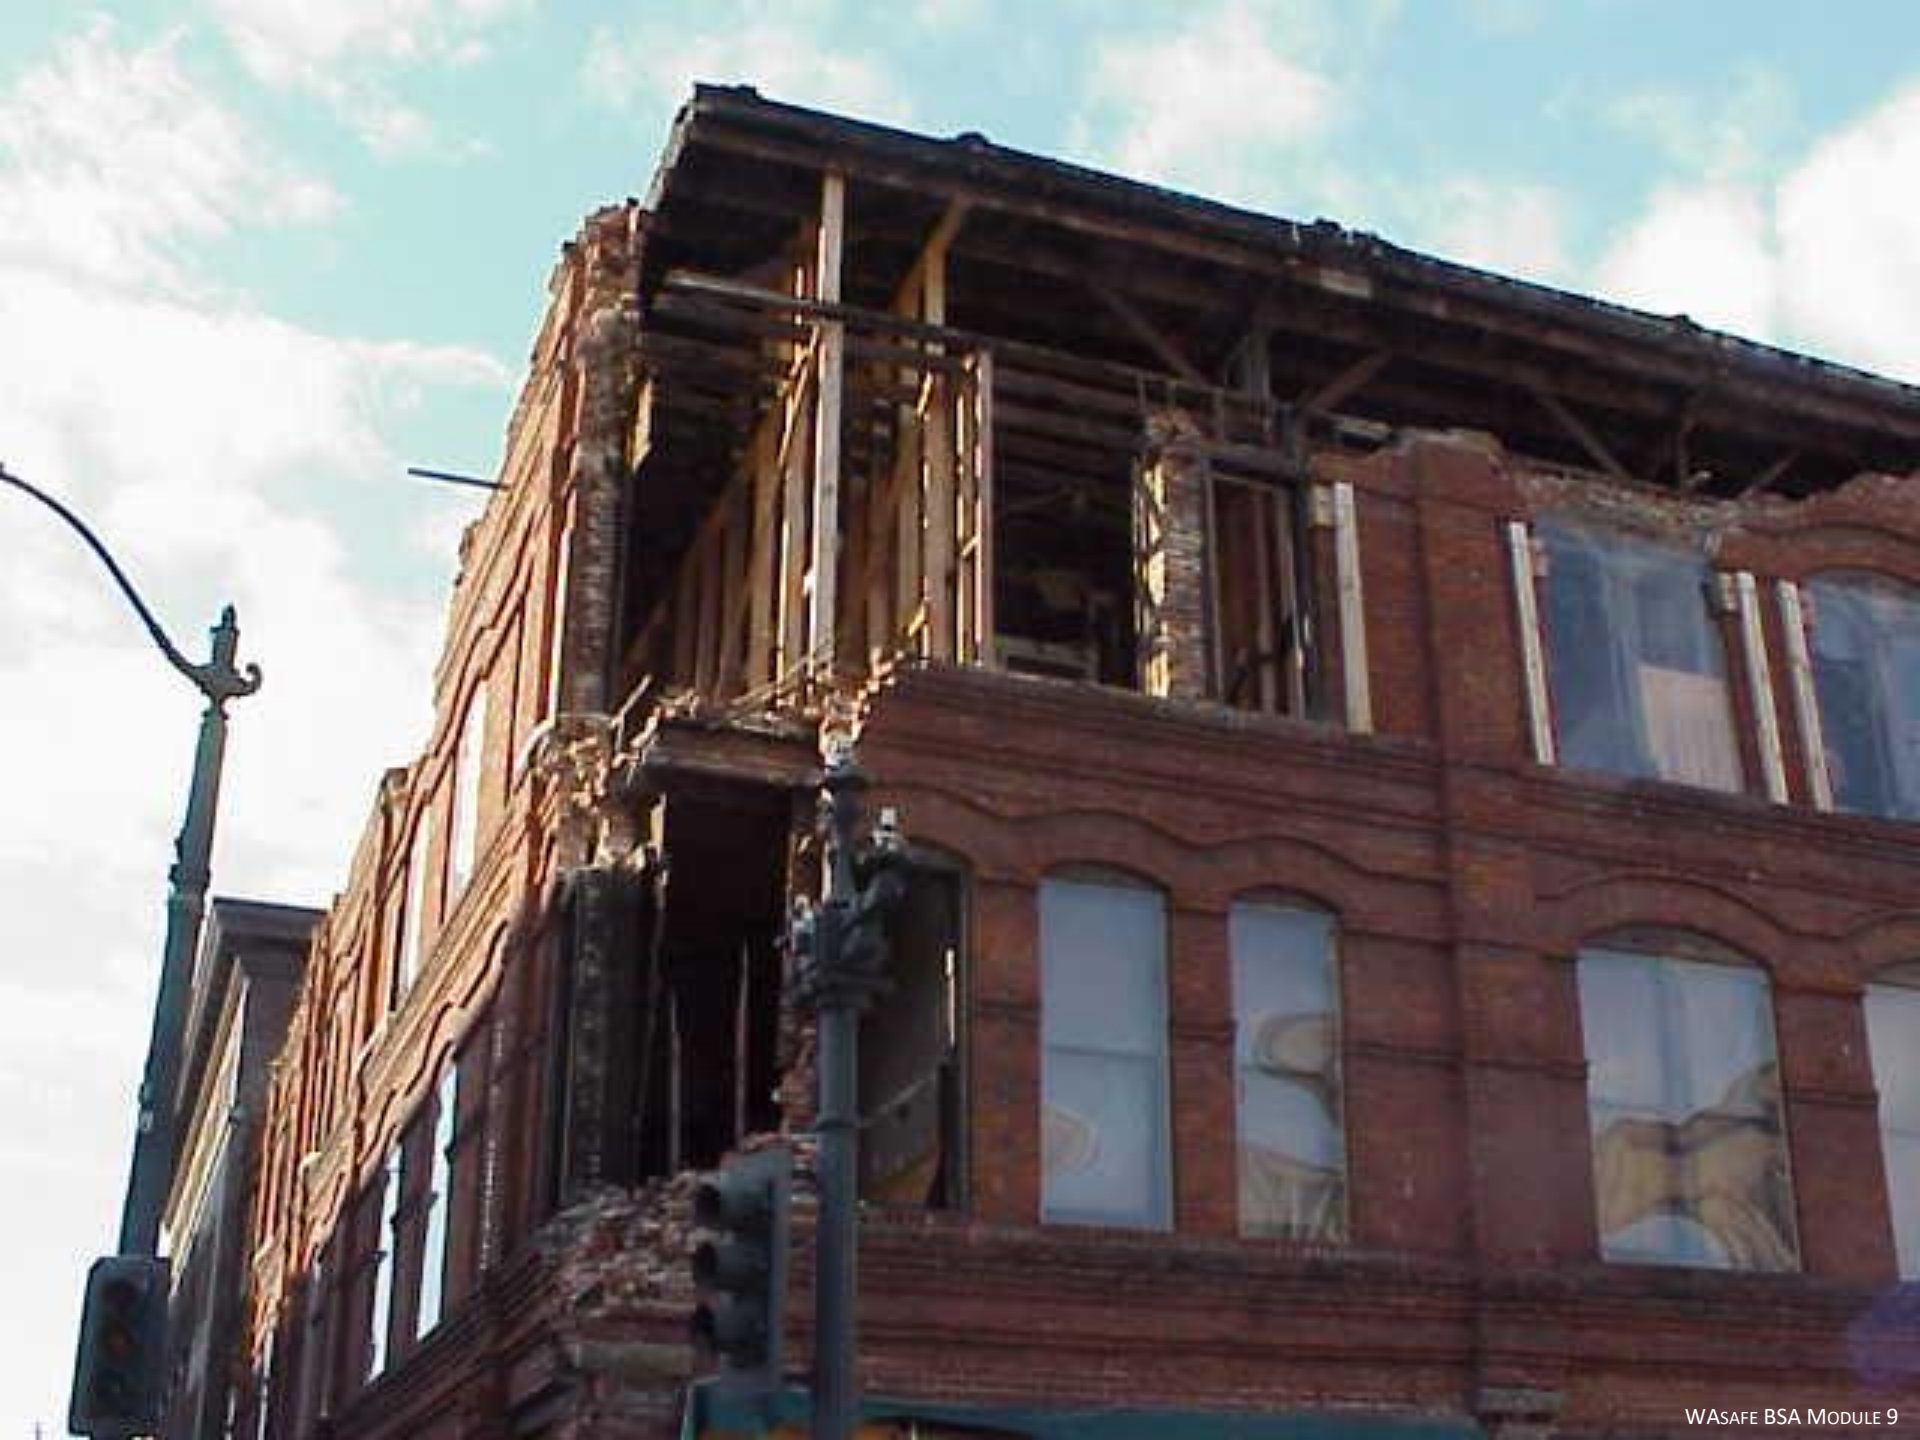
**BARRICADED
AREA SUBJECT
TO FALLING
HAZARD**

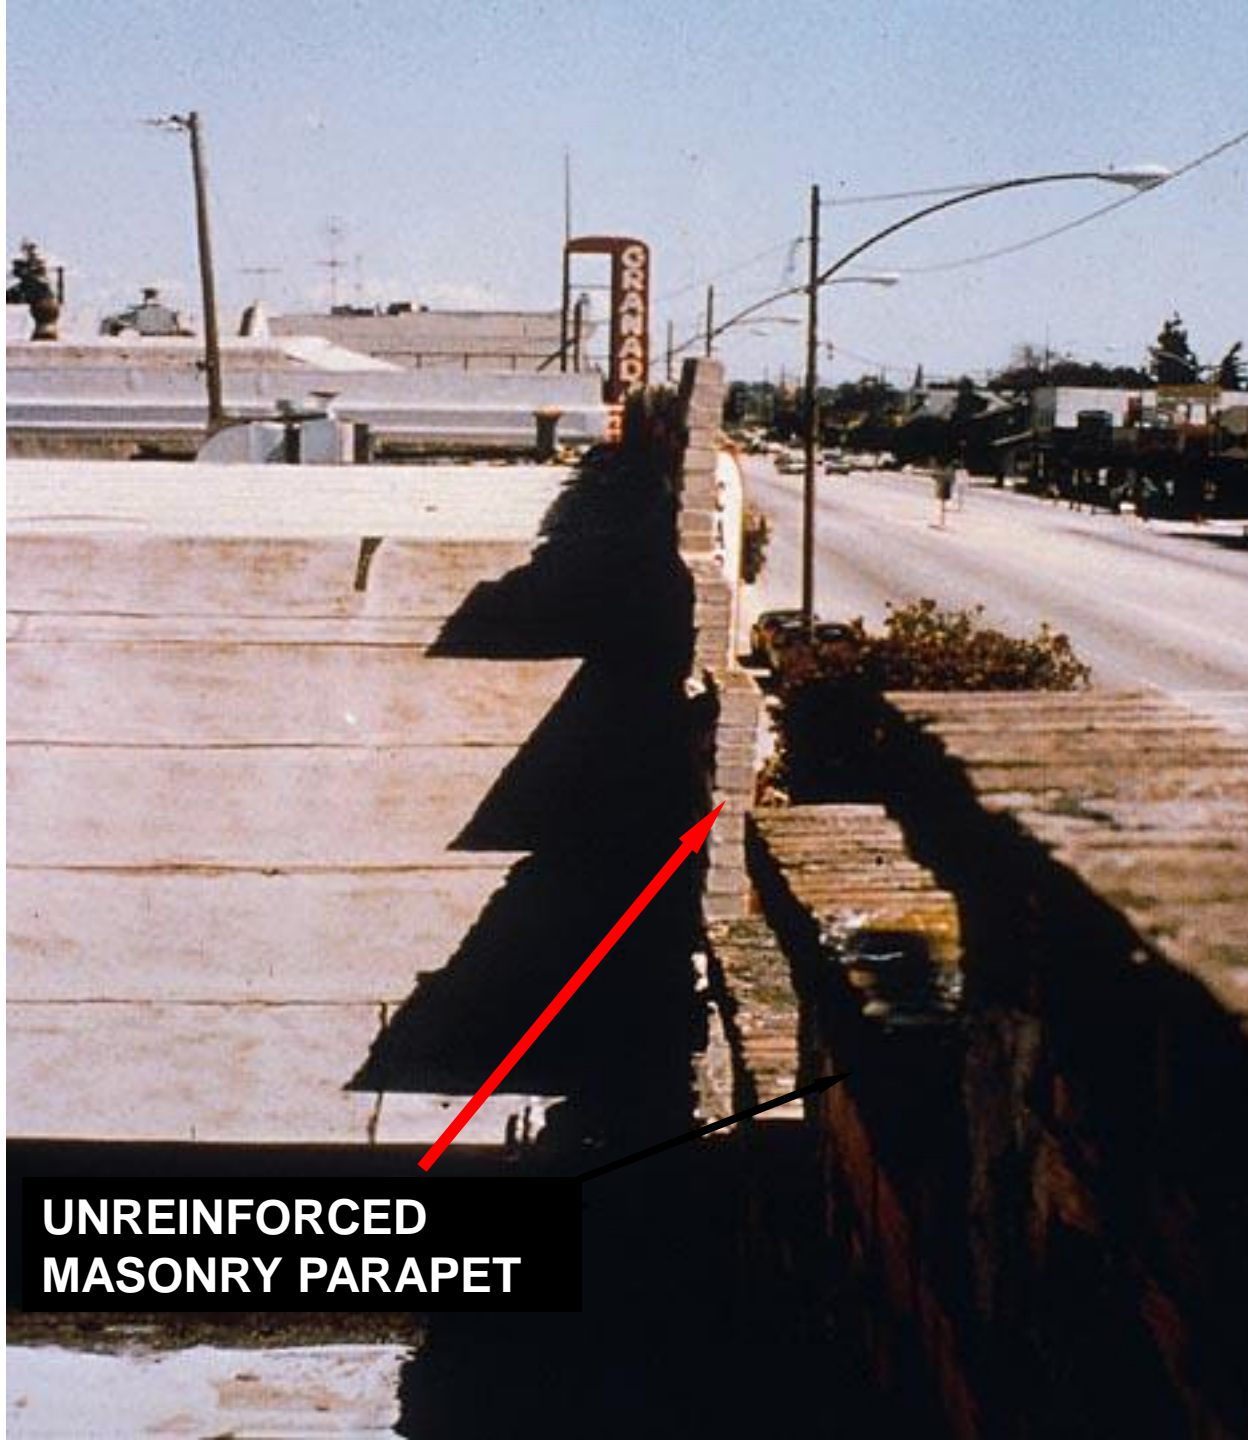
**UNREINFORCED
MASONRY PARAPET**

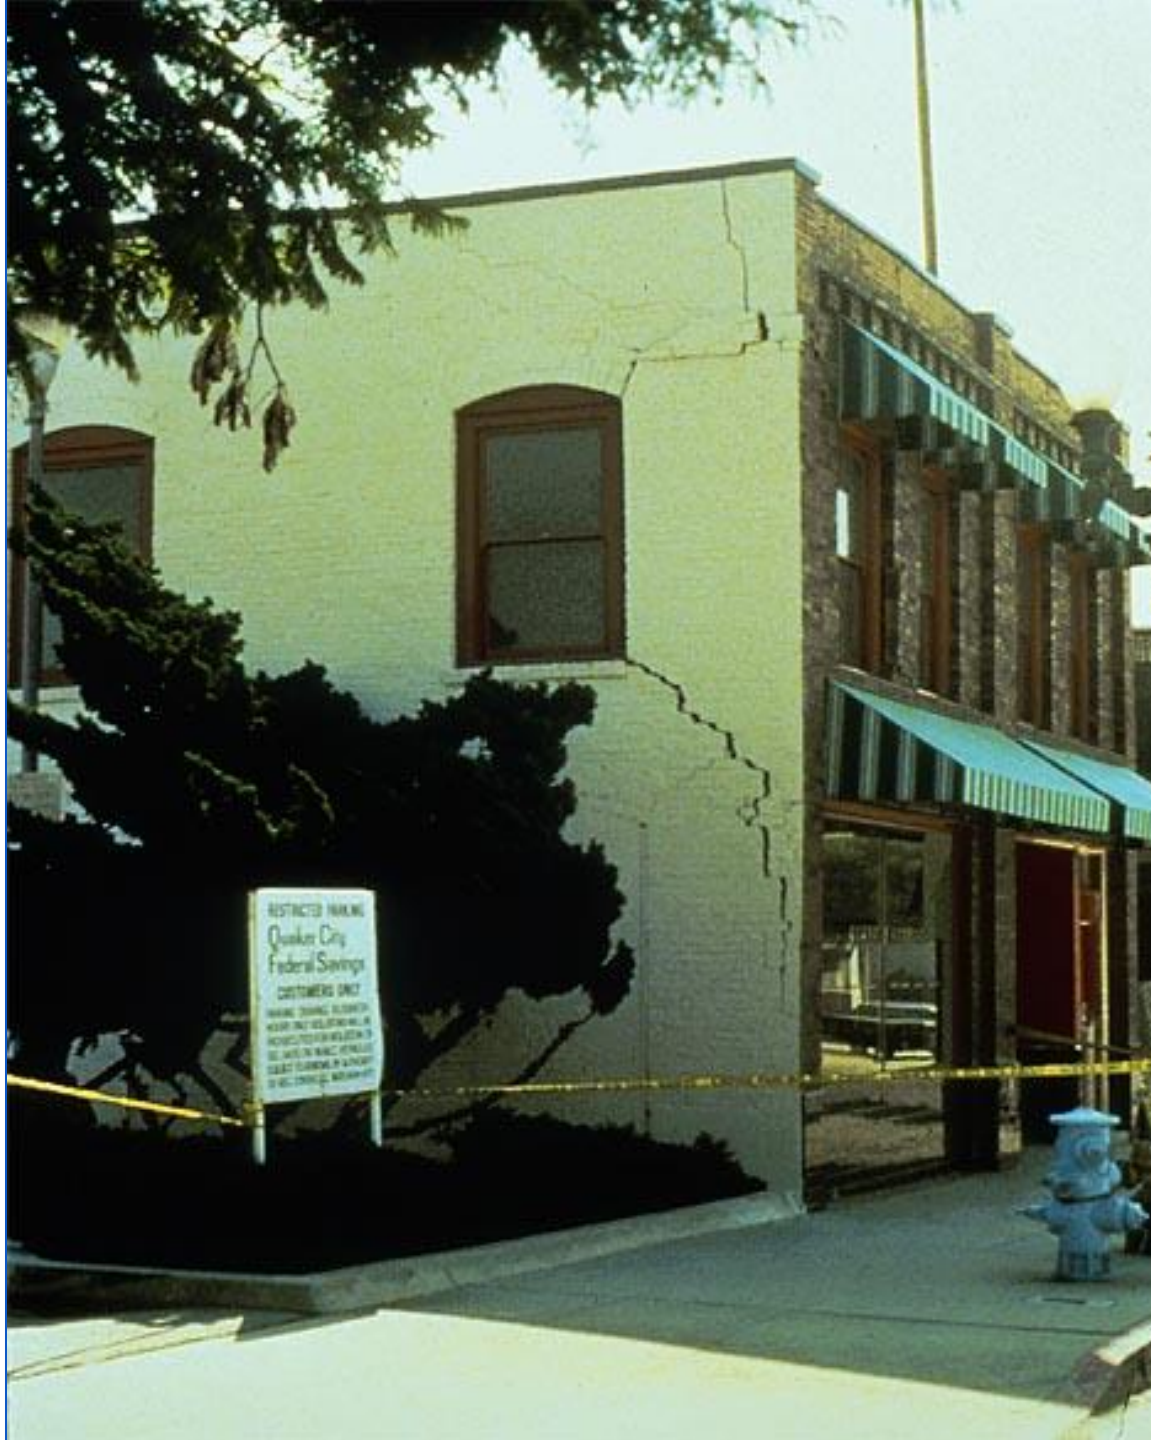
**STAIRSTEP CRACKS
USUALLY INDICATE
UNREINFORCED
CONCRETE BLOCK
WALL**

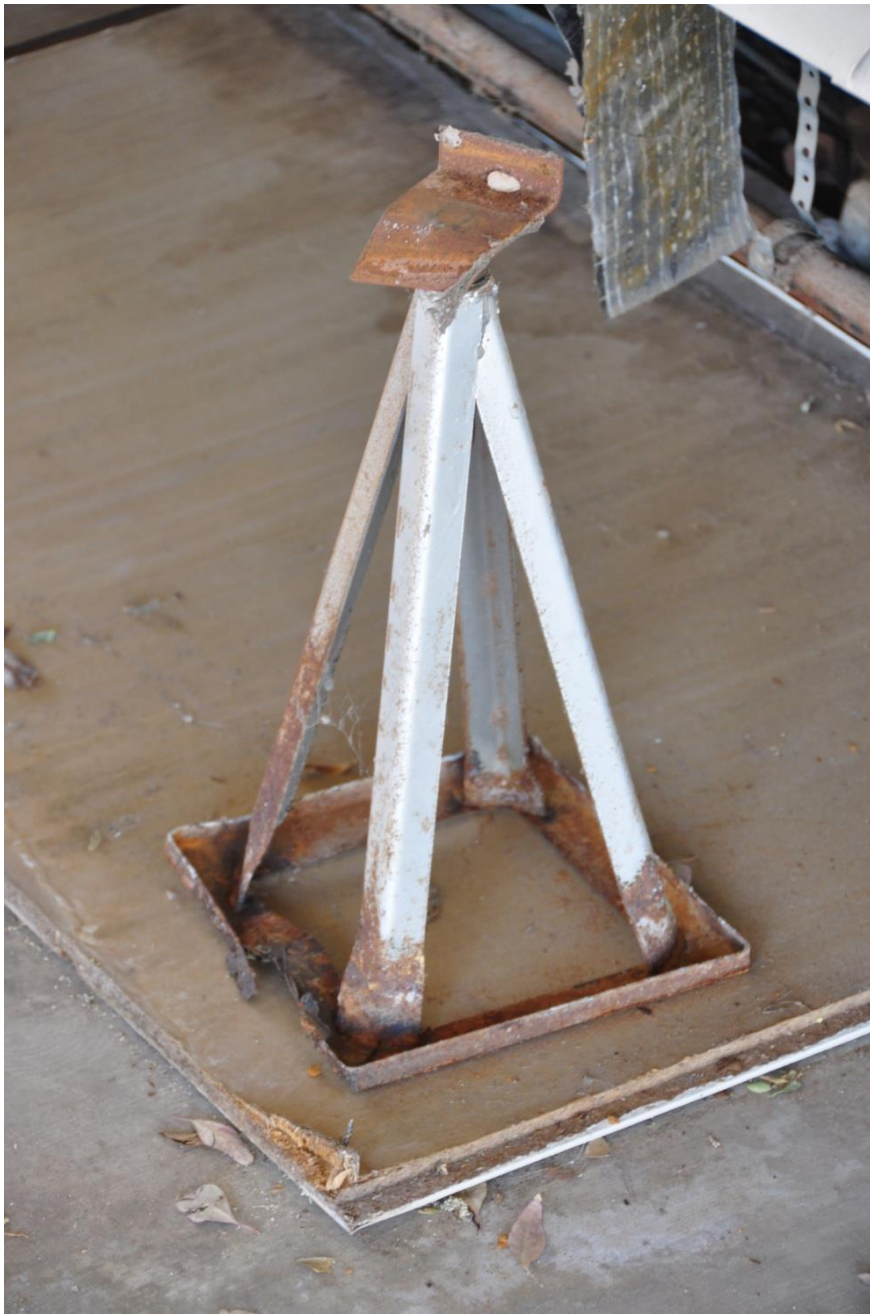
Example of a well-worn jack stand used to support manufactured home.

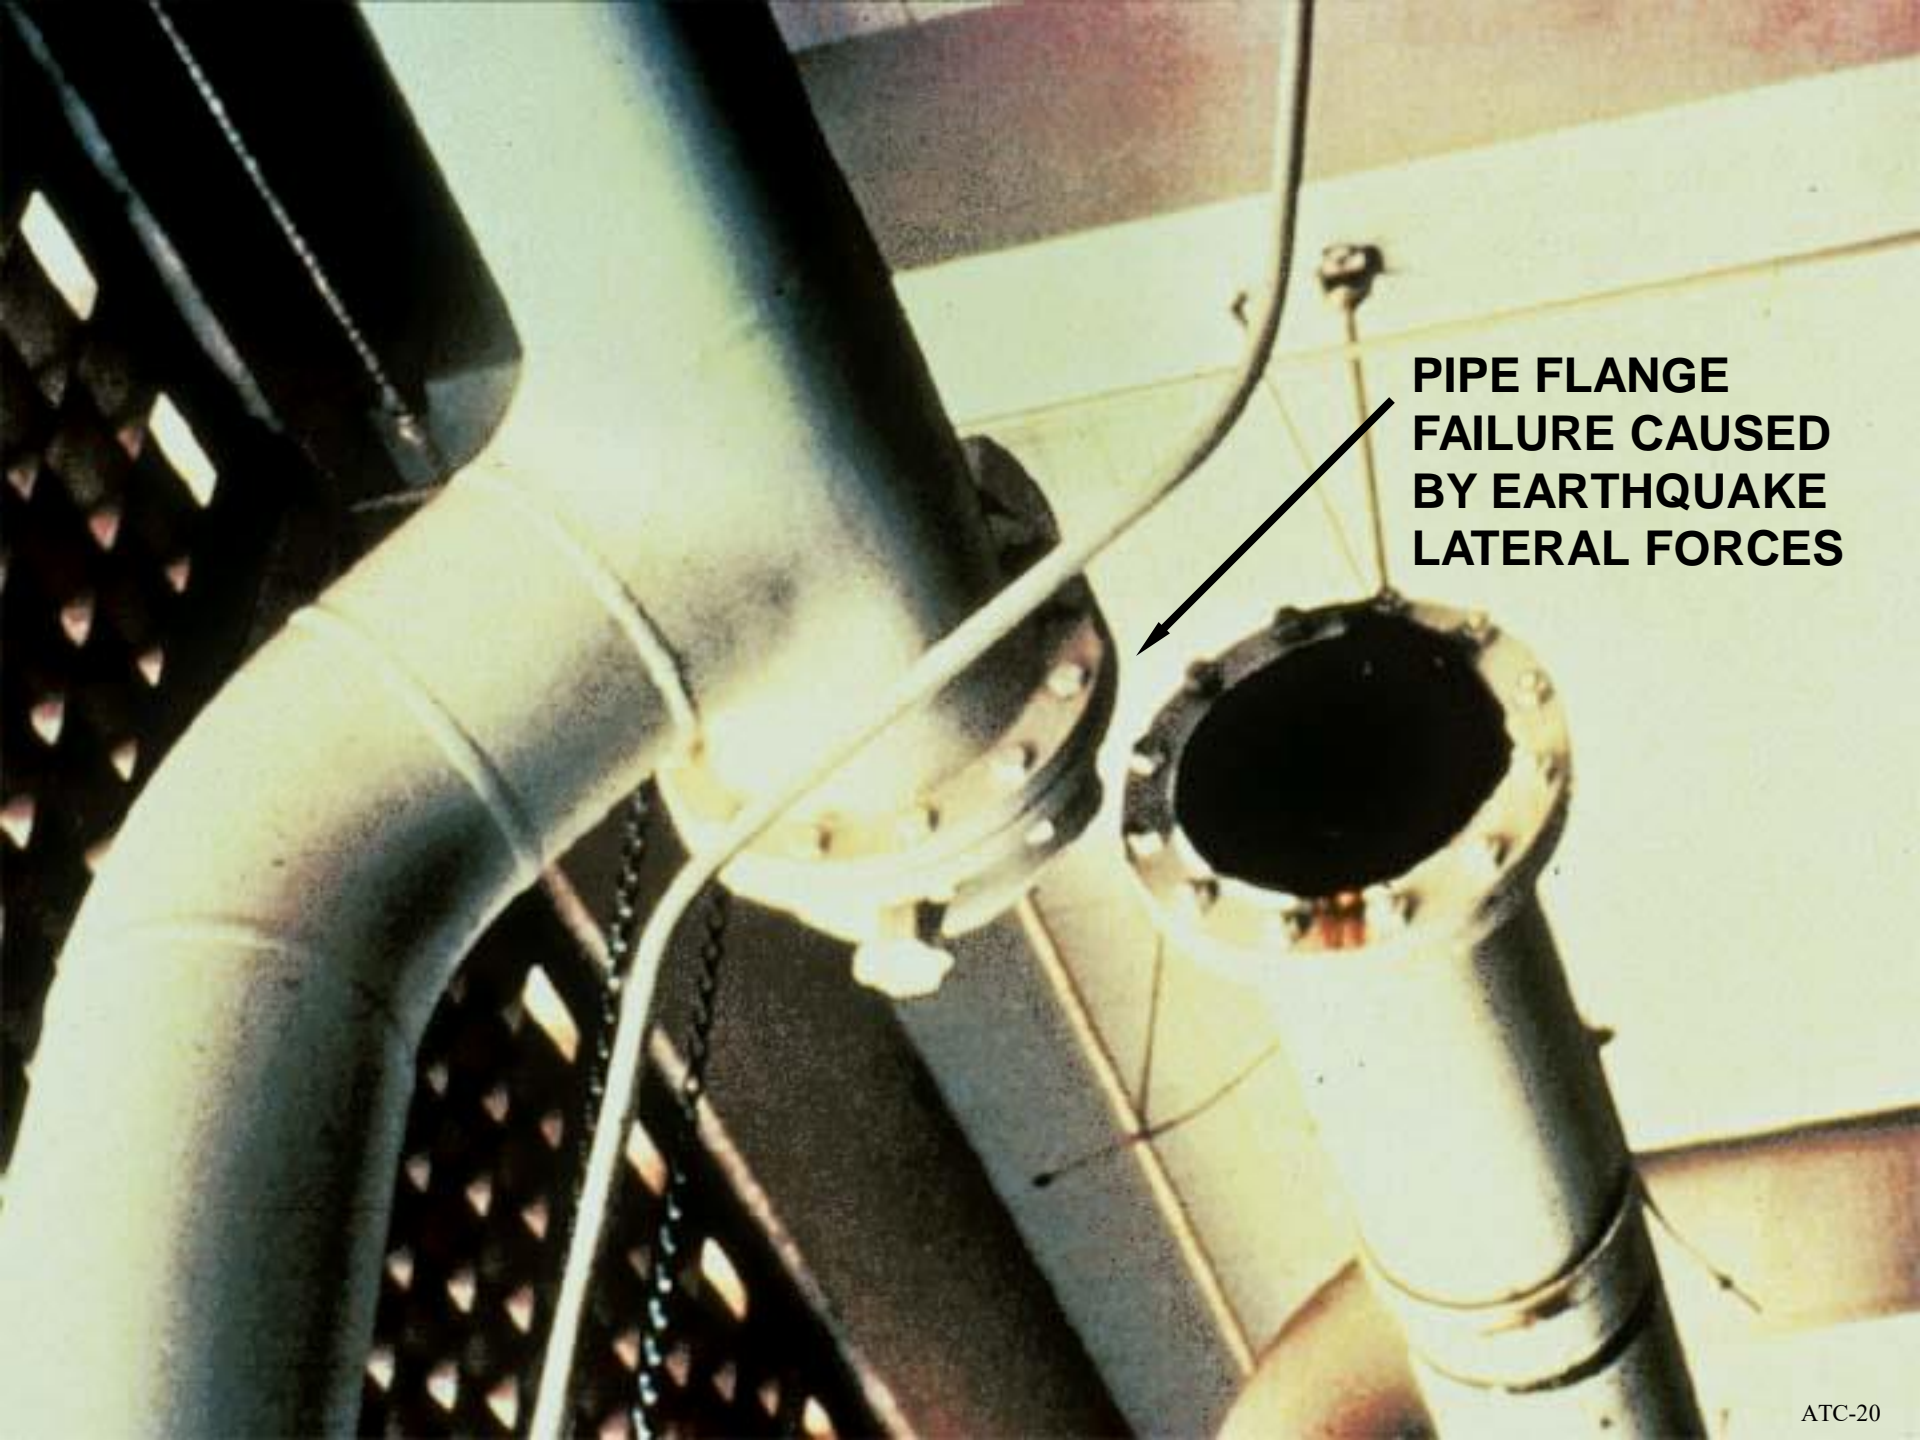
**PIPE FLANGE
FAILURE CAUSED
BY EARTHQUAKE
LATERAL FORCES**
