WOOD-FRAME CONSTRUCTION

MASONRY CONSTRUCTION

Postearthquake Safety Evaluation of Buildings

ATC-20

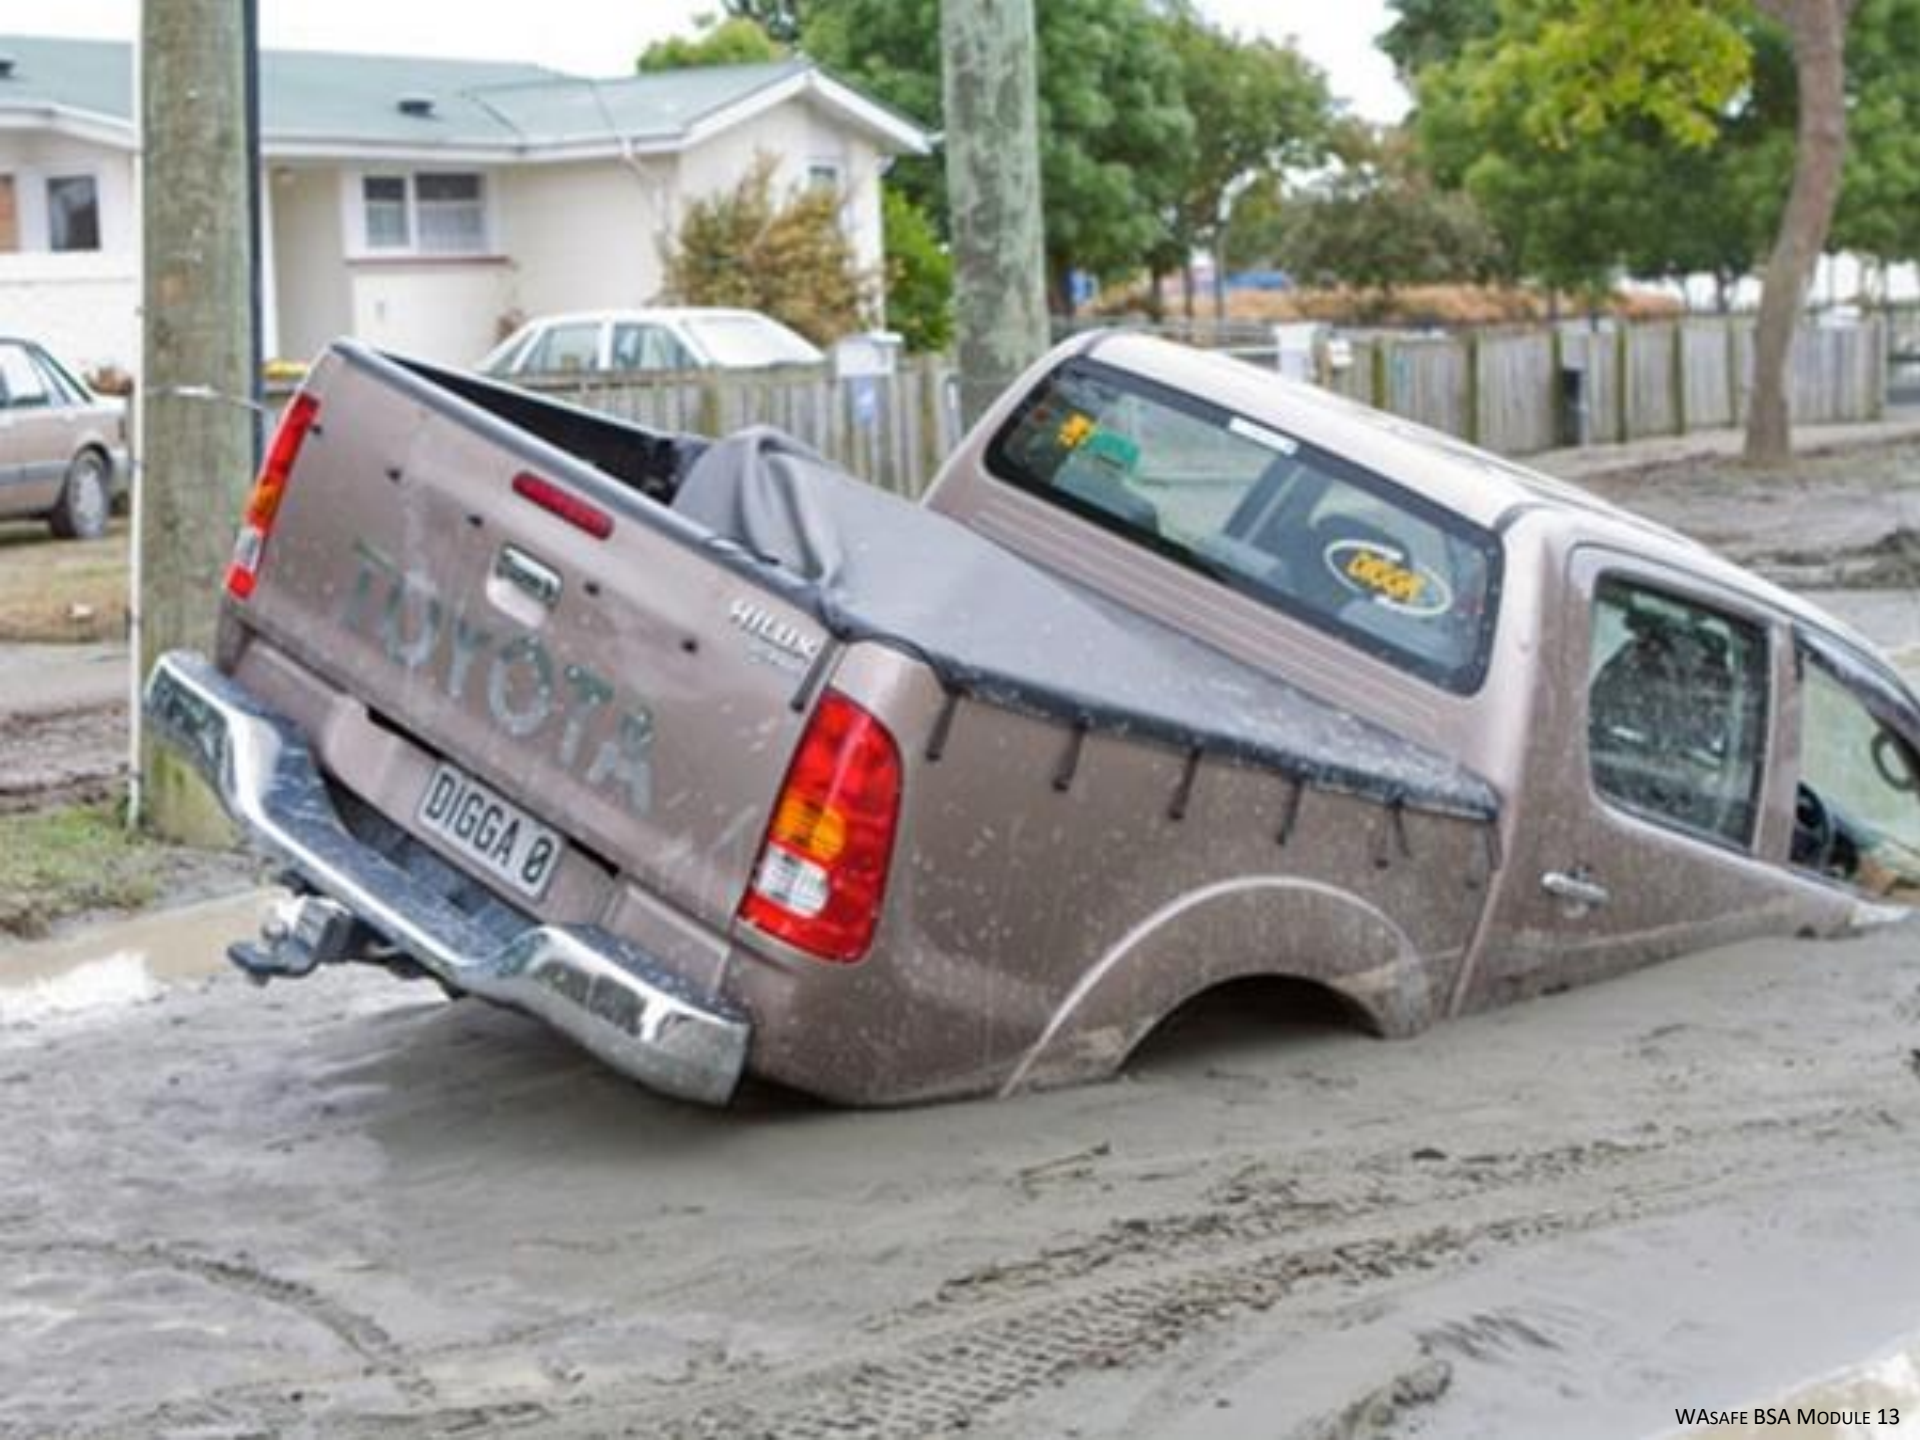
**BUILDING FOUNDATION
SETTLEMENT DUE TO
SOIL LIQUEFACTION**

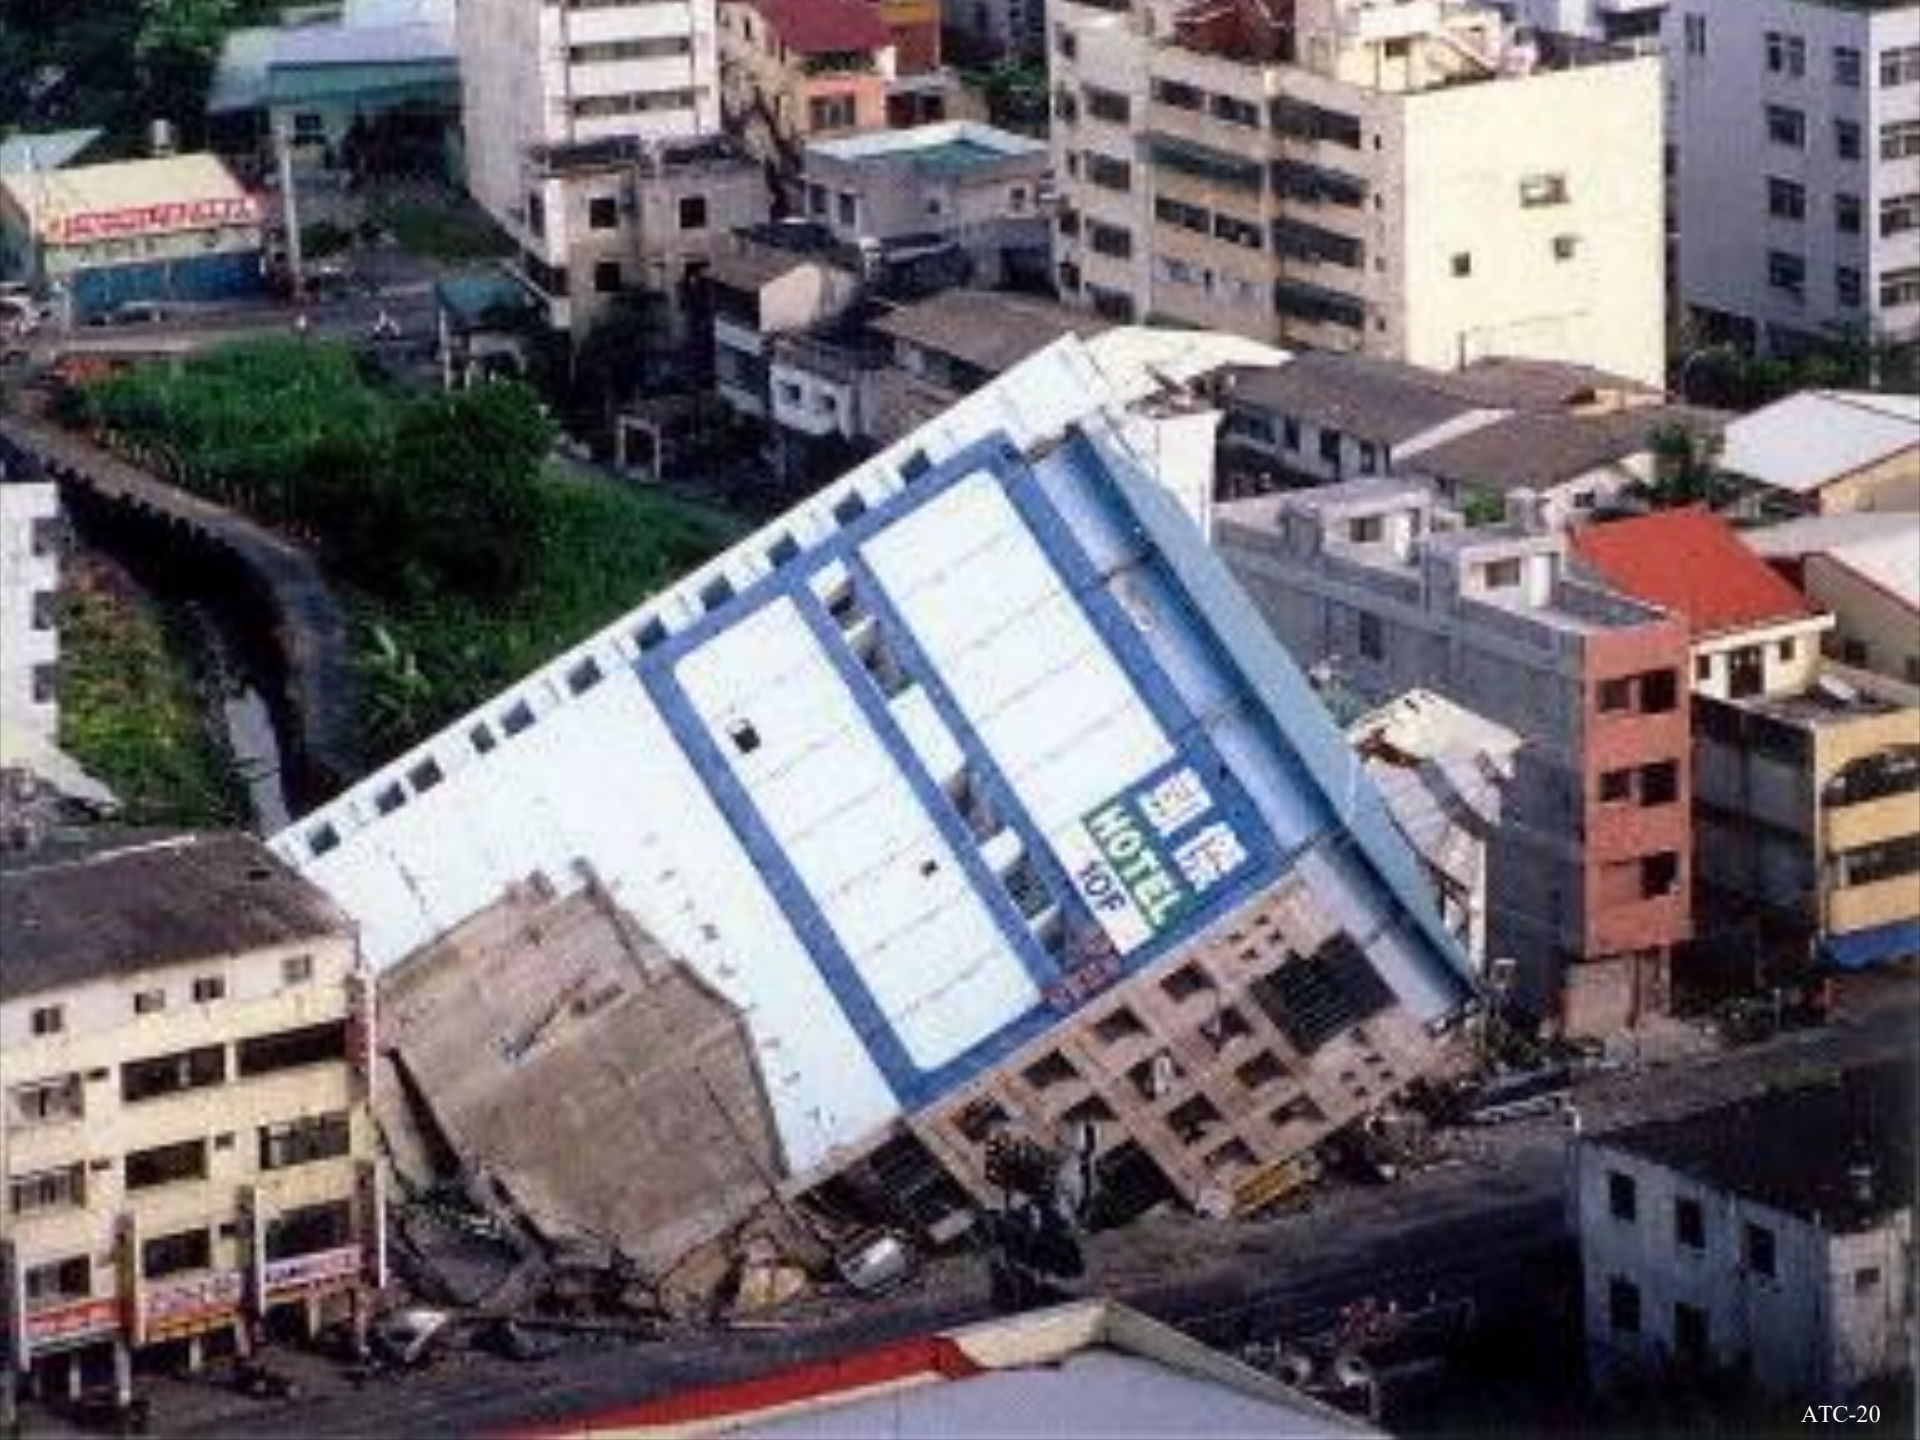
**PILE SUPPORTED,
NO SETTLEMENT**

**SHALLOW (RAFT)
FOUNDATION,
27" SETTLEMENT**

**GROUND, 15"
SETTLEMENT**

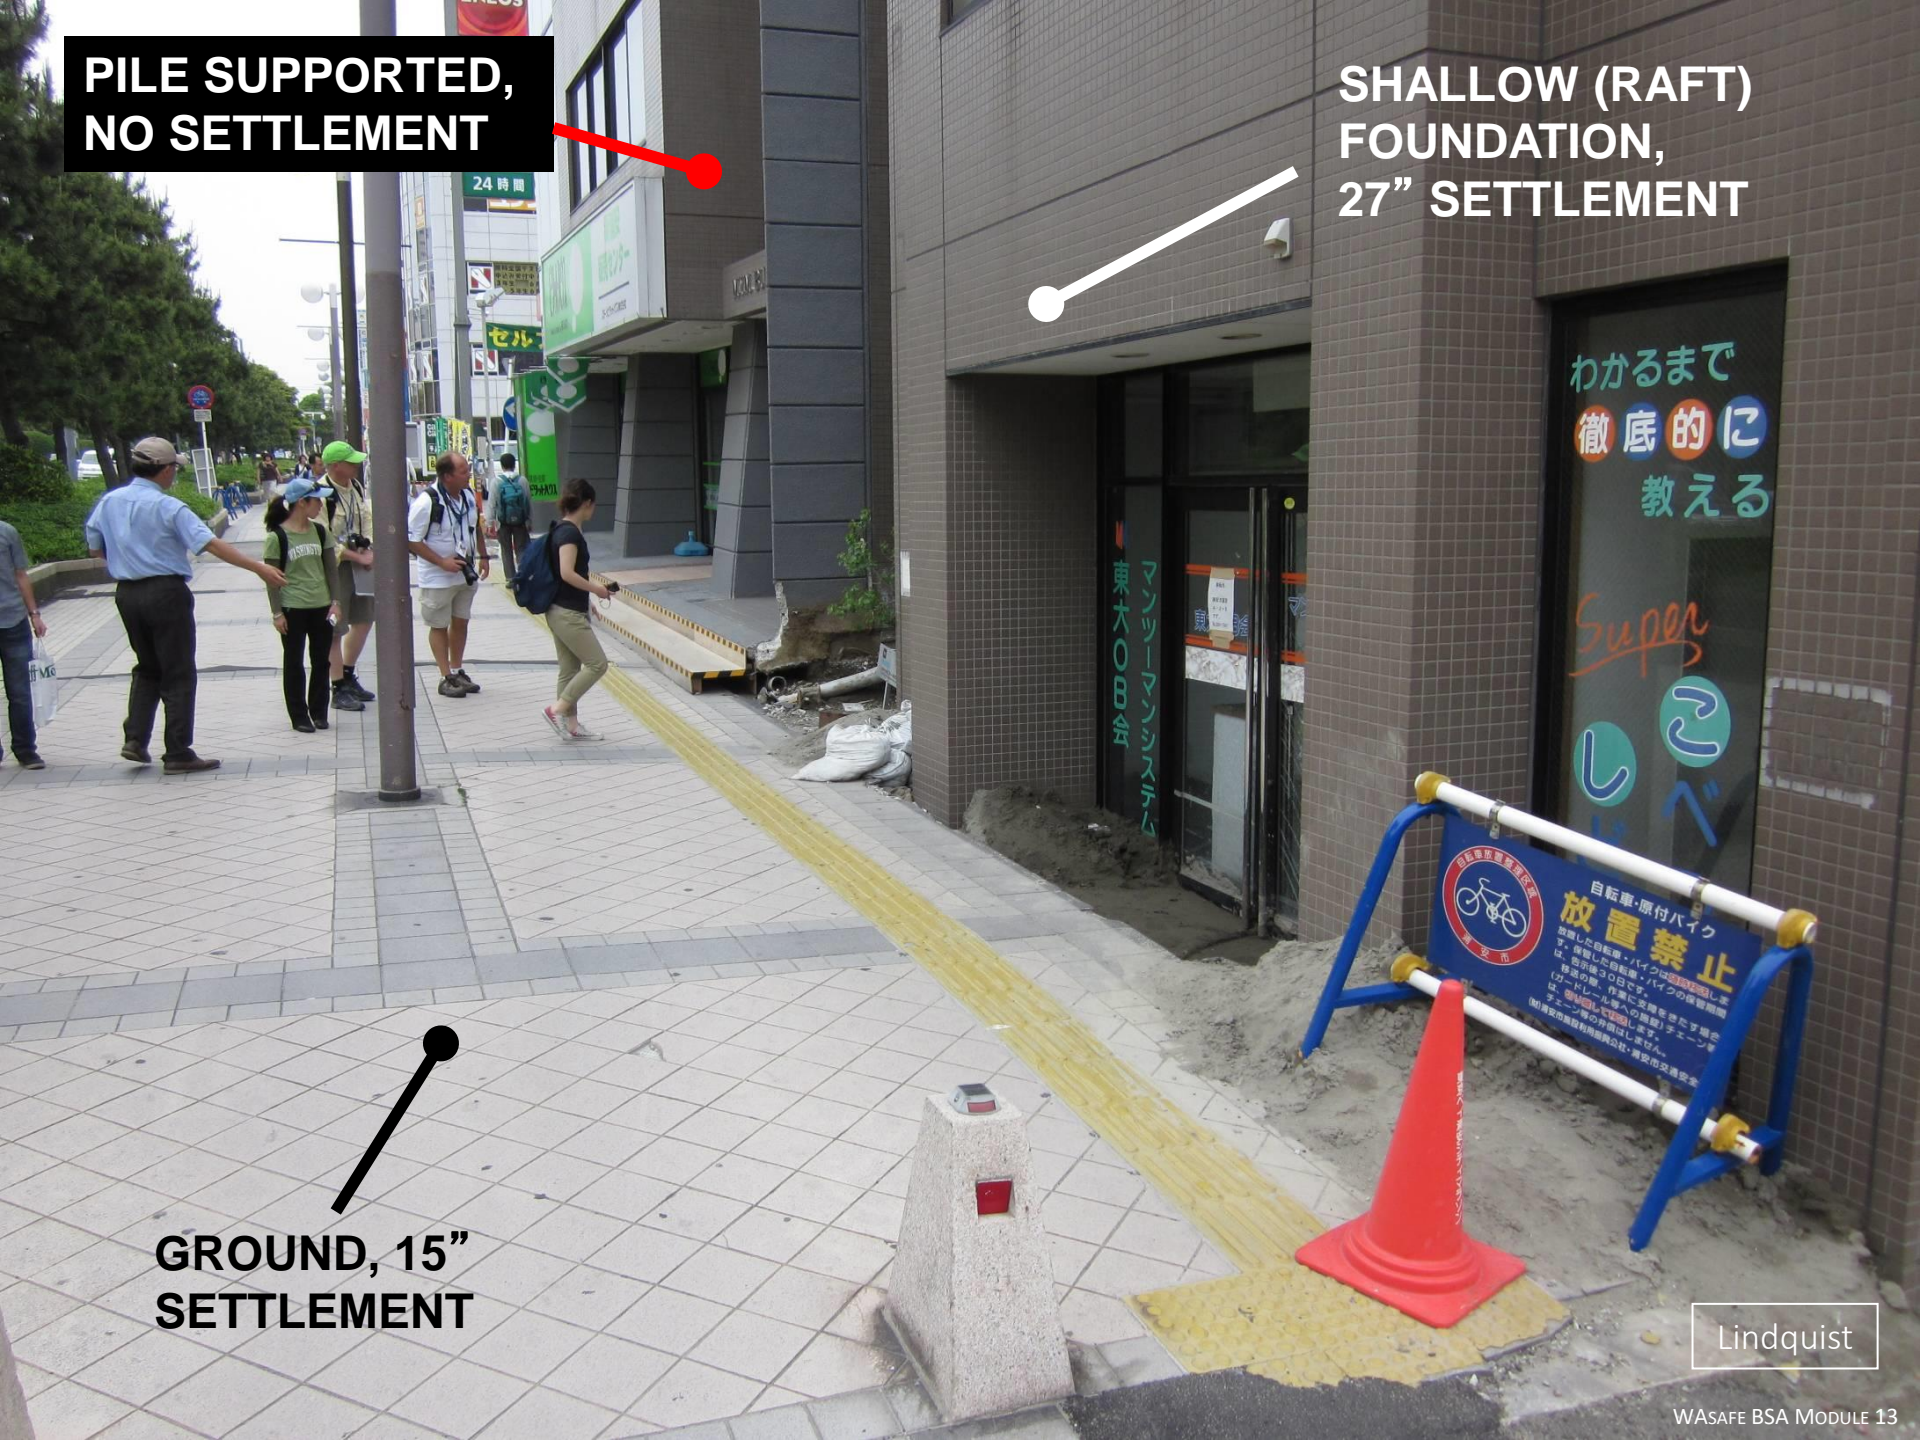
**BUILDINGS LEANING
BECAUSE OF FOUNDATION
SETTLEMENT DUE TO
LIQUEFACTION**
